Assessment of Changes in Channel Morphology in a Mountain River Regulated Using Grade Control Structures

Joanna Korpak¹

ABSTRACT

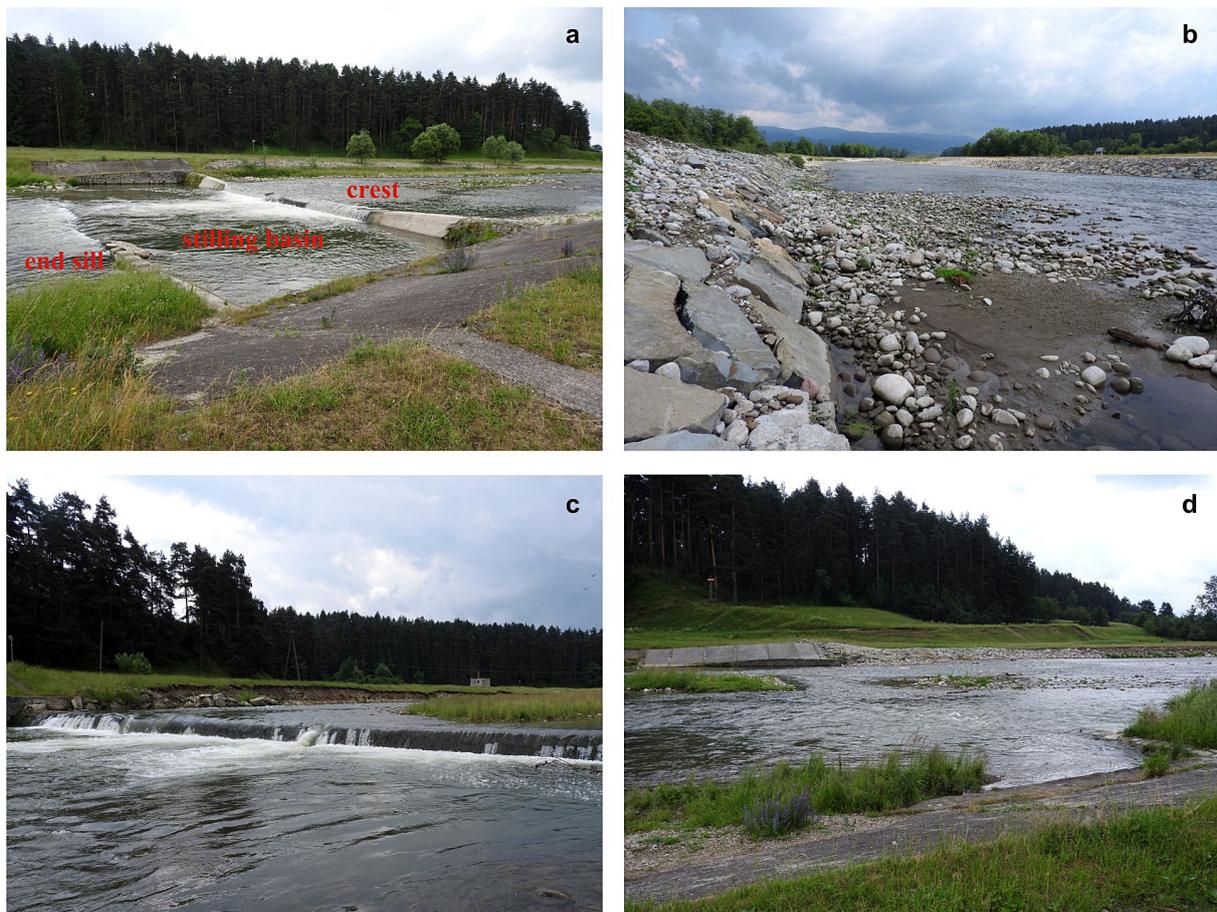
with GCSs. Major changes did occur in the long section 6–3, where riverbanks were newly created and reinforced (Photo 1b). Denudation forms present in this section were formed artificially and contained material from the riverbank readjustment process.

Photo 1. Channel section with grade control structures on the Biały Dunajec in the city of Nowy Targ: a – GCS, b – recreated and newly reinforced riverbank, c – damaged bank reinforcement and partly eroded GCS's crest, d – GCS covered with debris

in the course of regulation work. In many places the reinforcements were damaged and partly washed away (Photo 1c). In sections 10–9, 8–6, and 2–1 high bars covered with vegetation were noted along the left bank of the river. They were higher than the remaining bars, but lower than the floodplain. Cutbanks or reinforcements were found on opposing banks. Such a situation proves downcutting and a tendency of the channel to lateral migration.

GCS no. 9 was fully covered with debris. Its crest included a central bar (Photo 1d). Most GCSs had partly deteriorated crests and end sills downstream of stilling basins (Photo 1c).

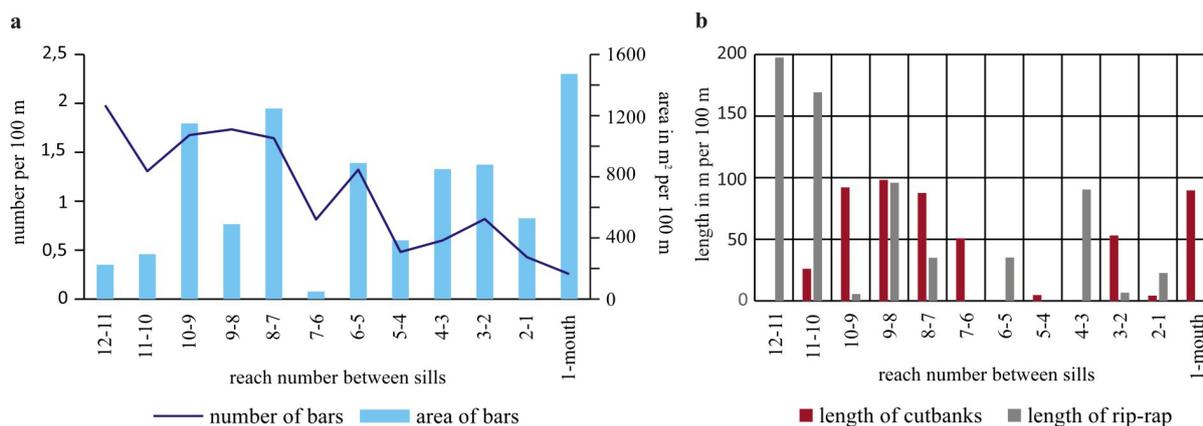
A small number of small bars were noticed across the studied part of the river channel. The number of bars per 100 meters of channel length never exceeded 2 and generally declined towards the mouth section of the river (Figure 3a). The bars were usually small in the upstream part of the study area (Section 12–10). However, one bar with a very large area was identified in the mouth section. The largest number of cutbanks were noted between GCS no. 10 and 7 as well as in the mouth section (Figure 3b). New reinforcements in the form of rip-rap was also noted (Figure 3b). Some of them were constructed in the course of repair work, while some may have been several years old. The remaining parts of the channel featured old reinforcements constructed

Figure 3. Fluvial forms and riverbank reinforcements recorded in the course of field surveys in 2019: a – number and area of bars, b – length of cutbanks and new bank reinforcements; all values are expressed per 100 m of channel length

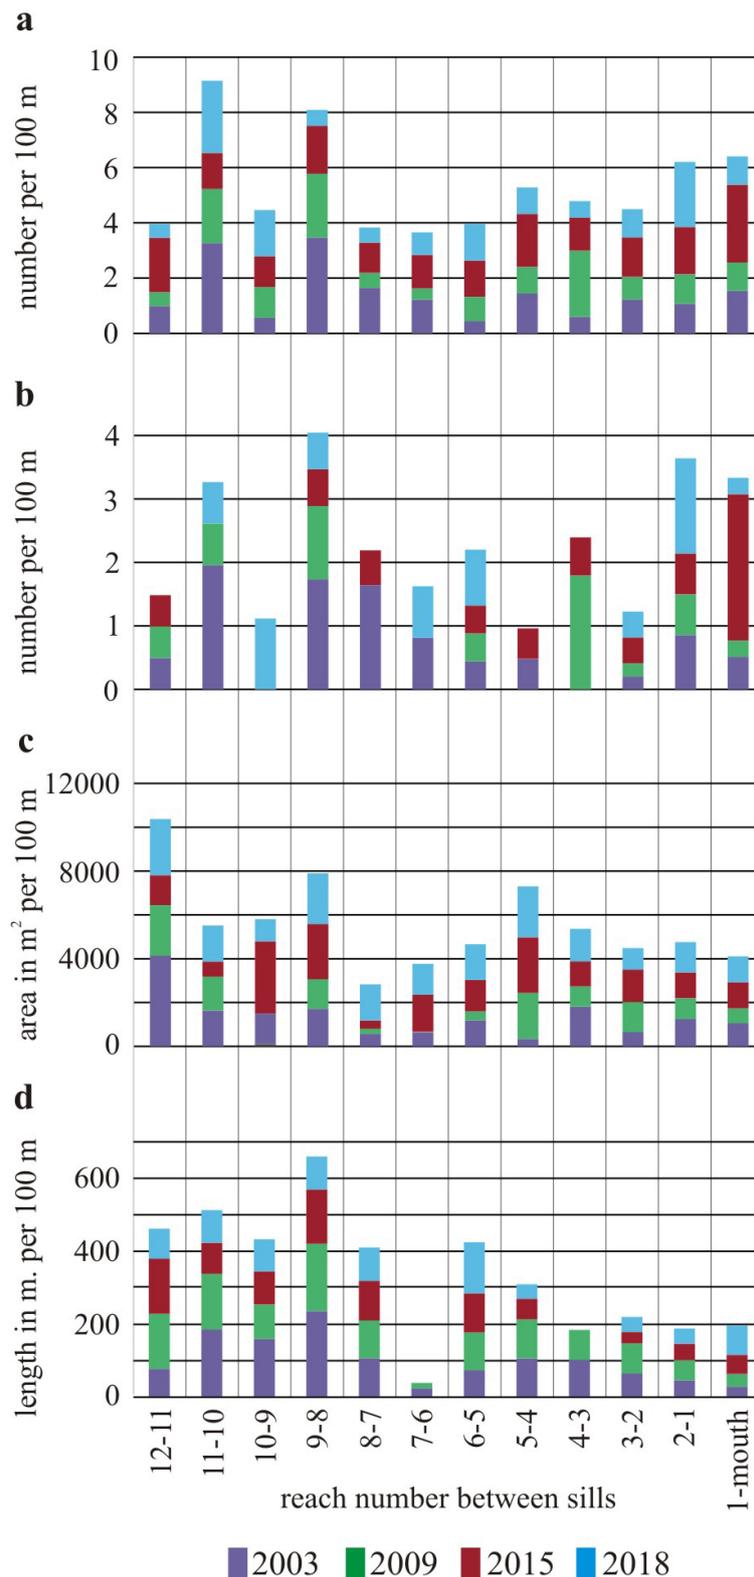
Research has shown that the largest number of bars formed in river sections 11–10 and 9–8 as well as between GCS no. 2 and the mouth of the river. The largest area occupied by bars was noted in sections 12–11 and 5–4 (Figures 4a, c). The role of deposition was found to be least important in sections 8 to 5. The largest number of central bars, which suggests braiding tendency, were observed in section 9–8 (Figure 4b). In addition, channel sections 11–10 as well as those between GCS no. 2 and the mouth of the river were characterized by the presence of a large number of central bars. The number of cutbanks tended to decrease towards the mouth of the river (Figure 4d) – their largest number was observed in section 9–8, while large declines were observed downstream of GCS no. 4. Section 7–6 was affected by some lateral erosion, as observed on photographs up to 2009, with no undercuts noted on photographs from 2015 and 2018. Narrow lateral bars covered with vegetation were identified, on all the studied photos, along the left bank in channel sections 8–6 and 2–1. Similar forms were also found along the left bank in section 10–9 in 2015 and 2018. Vegetated central bars were also observed in section 4–3 in 2009 and 2015. The presence of these forms implies the presence of downcutting.

Figure 4. Fluvial forms observed on aerial photos from 2003, 2009, 2015, and 2018: a – number of bars, b – number of central bars, c – area of bars, d – length of cutbanks; all values are expressed per 100 m of channel length

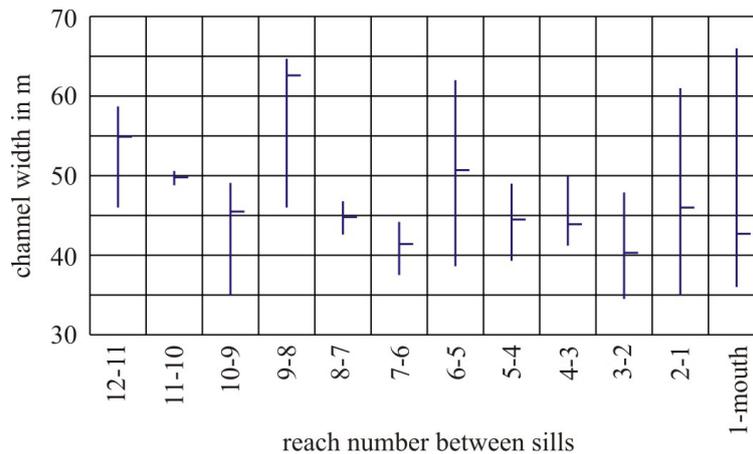
The initially uniform width of the regulated channel became highly variable (Figure 5). The mean width of the channel was 45.7 meters, according to an orthophotomap from 2018, ranging from 41.4 m in section 3–2 to 62.6 m in section 9–8 (section with largest number of undercuts). The largest differences in width were noted for the section from GCS no. 2 to the mouth of the river as well as sections 6–5 and 9–8. The most highly uniform channel width was observed for sections 11–10 and 8–6. In the first case, the cause of this was riverbank reinforcements. In the second case, it was the occurrence of high, vegetated lateral bars narrowing the profile of the river channel.

Figure 5. Width of river channel in sections between each GCS, measured on an orthophotomap from 2018

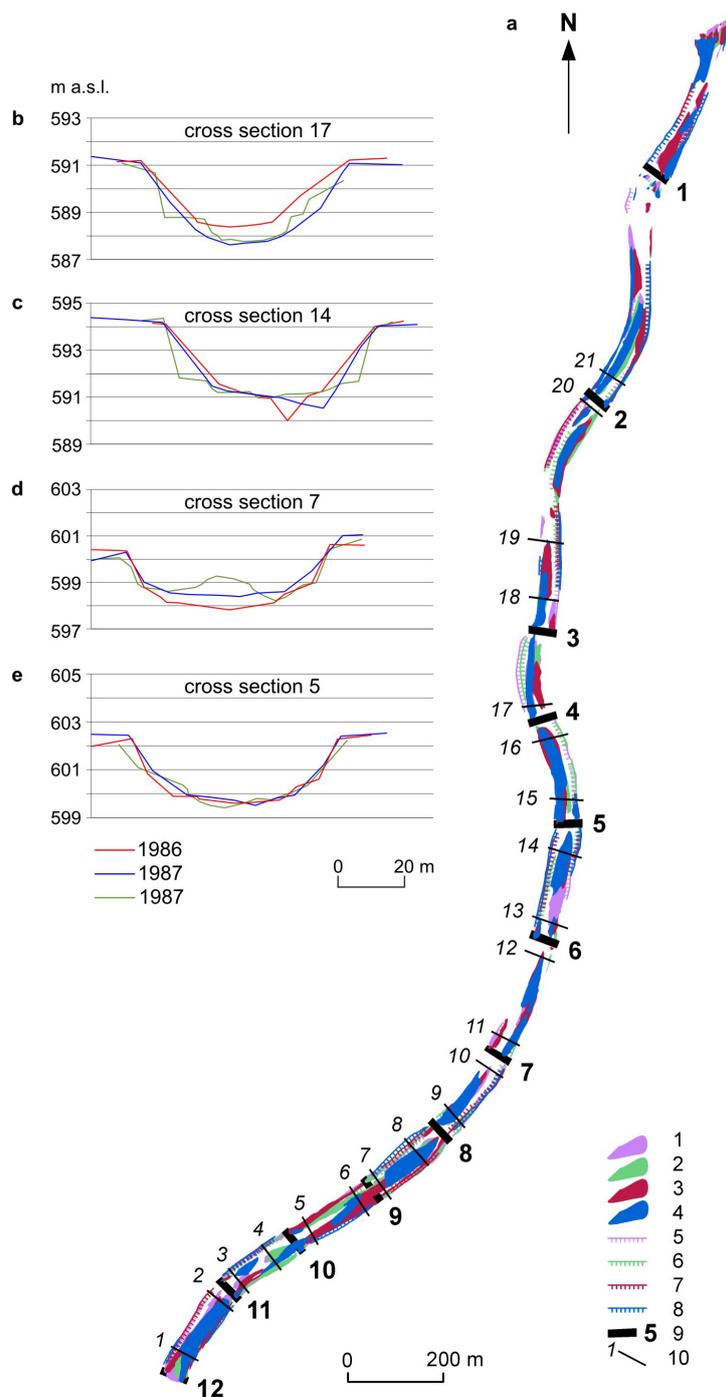
A side-by-side comparison of bars and cutbanks from all the aerial photos revealed main areas of deposition and lateral erosion that functioned during the study period (Figure 6a). It turns out that the location of the largest bars and cutbanks is similar from year to year. This does not apply to sections 12 to 8, where bars formed at multiple locations and both riverbanks were undercut. In subsequent sections one may easily observe a tendency of concave riverbank erosion as well as deposition under convex riverbanks. In the case of straight sections, such as section 6–5, central bars form and both riverbanks become eroded. Hence, the right bank of section 8–7 is eroded, left bank of section 7–6 is eroded (short segment downstream of GCS no. 7), right bank of section 5–4, left bank of section 4–3, first the right bank and then the left bank of section 3–2, and finally right bank of section 2–1. In the section between GCS no. 1 and the mouth, both riverbanks are eroded, but bars form mainly close to the right bank and right at the mouth of the studied river.

This prompts the following question: What is the scale of observed changes over the course of the entire study period? The answer to this question is provided by an analysis of cross sections for the years 1986 (immediately after regulation work), 1987 (after first major flood), and 2019 (after 33 years of the functioning of GCSs) made for the same locations along the studied channel (Figure 6). It is important to remember that measurements collected in 2019 were performed right after repair work on the channel of section 6–3 (Figure 6c).

erosion was noted in section 4–3. Its increase in channel depth in the years 1986–1987 reached a maximum of 73 cm (Figure 6b). However, in later years some deposition was observed. The largest increase in channel depth in each studied year is noted at the same location – most frequently under one riverbank. The largest deposition occurs in section 9–8, where the height of the channel bed increased by an average of 41 cm in the years 1986–1987; however, a small decrease has been observed in 2019 (Figure 6d). Vertical stability was observed in sections 10–9 and 8–6 (Figure 6e). Analysis of horizontal changes associated with lateral erosion showed that the displacement of a riverbank, triggered by a single flood event, may be as large as approximately 10 meters. However, many repair works have been performed in the years since, and the location of riverbanks in the studied channel is now similar to that in 1986. The maximum shift of the channel bank is approximately 11 m above GCS no. 8.

Figure 6. The changes of river channel morphology: a – location of bars and cutbanks in the years 2003, 2009, 2015 and 2018: 1–4 – bars present in the following years: 2003, 2009, 2015, 2018, 5–8 – cutbanks present in the following years: 2003, 2009, 2015, 2018, 9 – GCSs with their numbers, 10 – cross sections with their numbers; b-e – cross sections of the channel in years 1986, 1987 and 2019: b – in the section with downcutting, c – in the section recreated and newly reinforced in 2019, d – in the section with deposition, e – in the stable section
