INFLUENCE OF EXTREME DISCHARGE ON RESTORATION WORKS IN MOUNTAIN RIVER – A CASE STUDY OF THE KRZCZONÓWKA RIVER (SOUTHERN POLAND)

Keywords: mountain river maintenance, river channel processes, artificial riffle, debris dam reconstruction.

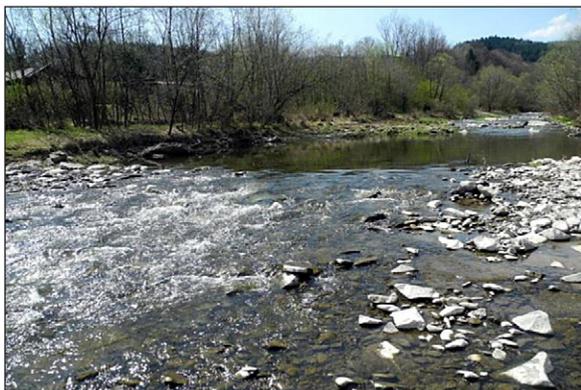
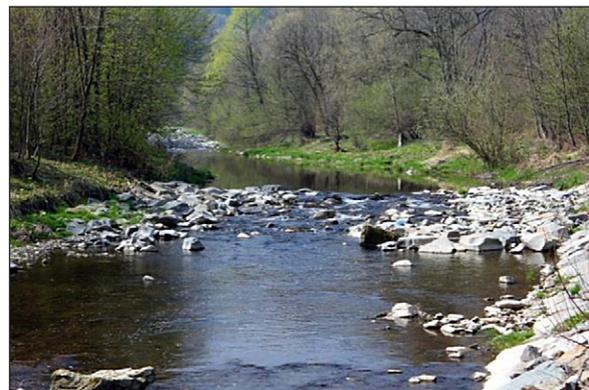
Photo 1. Sample two out of 12 riffles constructed in the Krzczonówka River

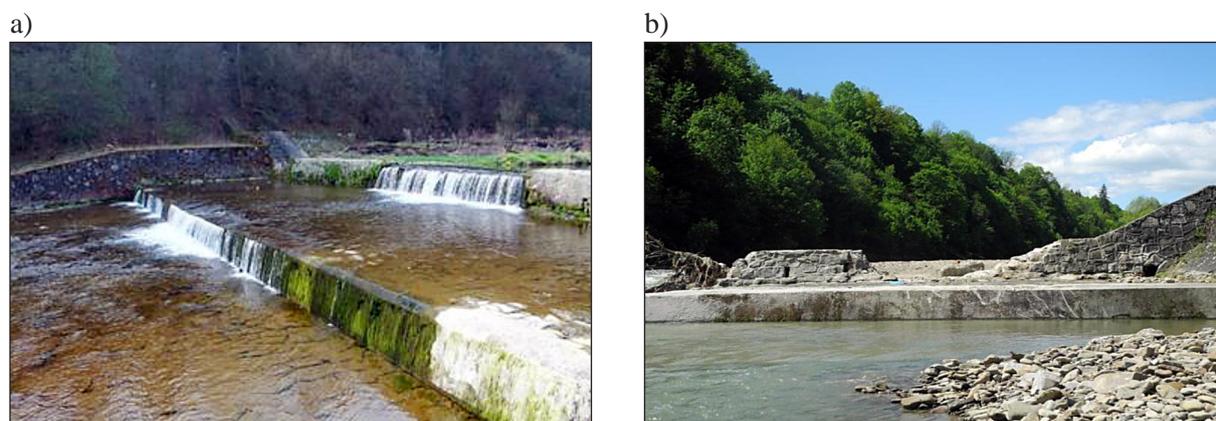
Rains and high discharges coincided in time with the modernization works performed on the

Photo 2. Debris dam on the Krzczonówka River at km 2 +440, a – the dam before modernization, b – the dam during modernization, after the high discharge event

debris dam. In effect, this caused large amounts of sediment to be transported at the time. This, in turn, caused significant changes to the segment of Krzczonówka River being described.

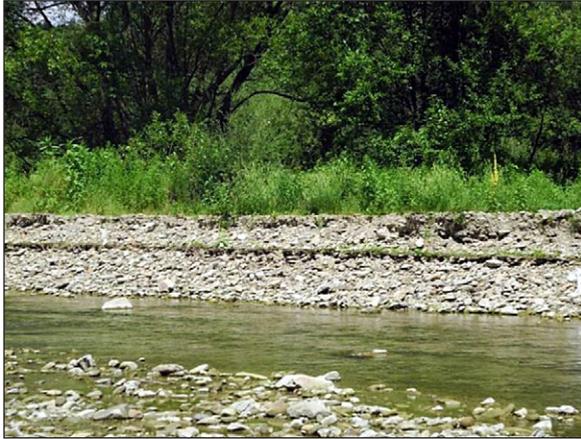
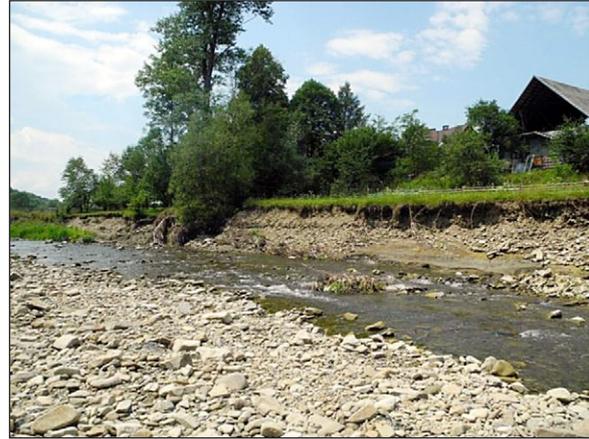
An analysis of cross sections upstream of the debris dam, which is being lowered, shows that this segment of the channel has also been substantially transformed. Large amounts of sediment, entrained by the high discharge event, caused sudden erosion over a long stretch of the channel. Its effects are visible along a 2 km long channel segment above the dam. A selected cross section, located in the reservoir part of the dam, is shown in Figure 11. It can be seen that the stream bed

Photo 3. Cutbanks found in the stream segment above the debris dam, which is being lowered

lowered by about 1.8 meters. The cutbanks found in the stream segment upstream of the debris dam are shown on the selected photographs (Photo 3).

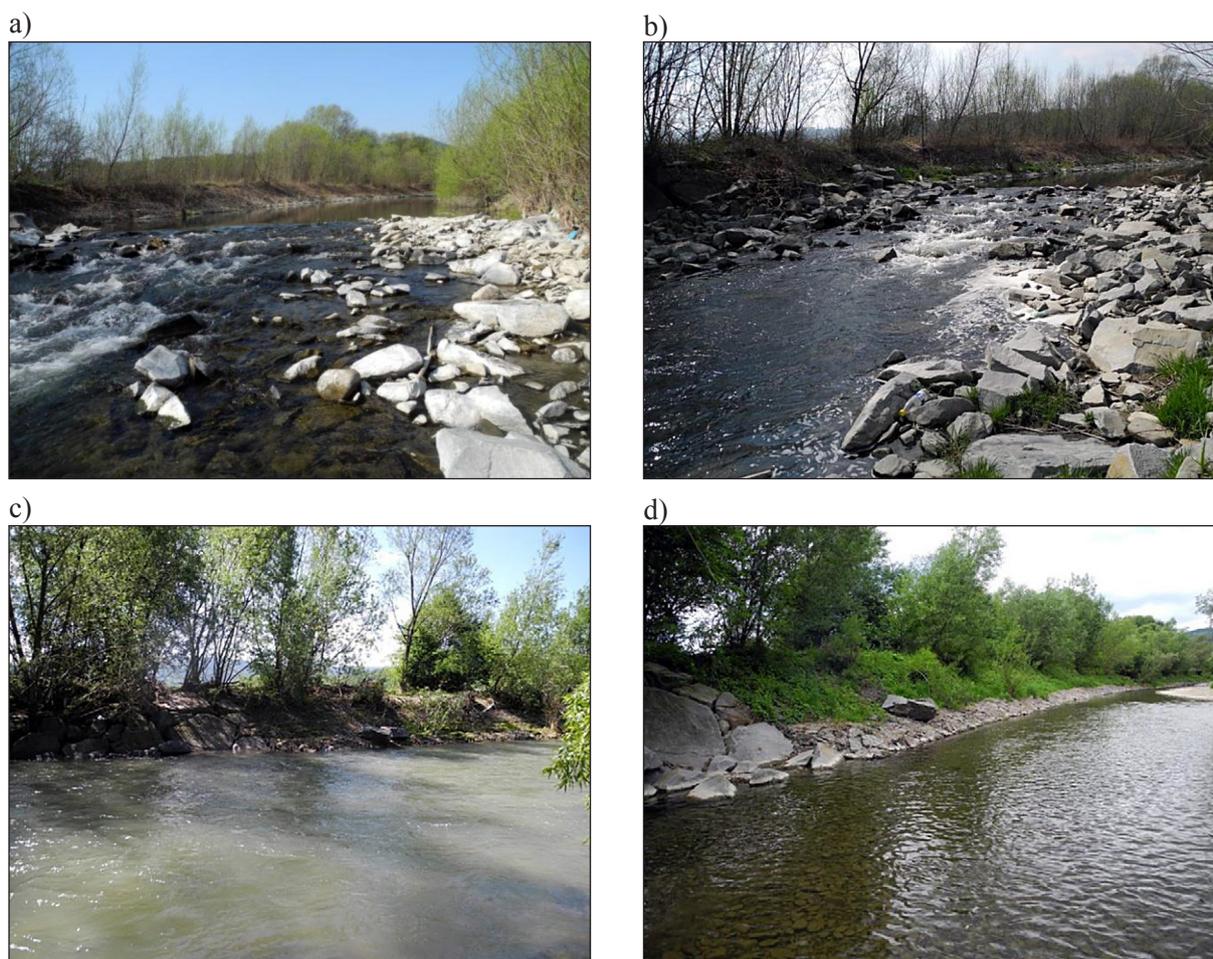
A field inspection of the riffles constructed in the lower reach of the river, close to the river mouth, produced doubts as to their durability. Accumulation that occurred there was minimal (Table 2). Furthermore, erosion is observed at cross section No. 20 (Figure 10). The very high flow and limited transport of sediment both weakened the most downstream structures. Riffle No. 16 has been entirely washed away. The subsequent phases of washing away of the riffle are shown on the photographs (Photo 4).

The river slope just upstream from a riffle crest is smaller, so the flow velocity is also small, whereas the water flowing over the riffle accelerates. The structure of a riffle remains unchanged at low flows. However, increasingly higher flows cause washing away of ever larger grained sediment. In effect, after a while, only the frame of the structure remains, which is not wedged by smaller supporting structural elements (Photo 4b). Concurrently, a dip in the river bed is created at

Photo 4. Phases of washing away of riffle number 16: a – spring of 2013, right after it was built; b – April of 2014, loss of small-grained sediment is seen, c – May of 2014, after the maximum flow event, d – June of 2014, no trace of the structure built last year

high flows, just downstream from the riffle. The dip becomes ever larger, and it decreases the energy of the flow. The next stage involves shifting of major structural elements due to the action of flowing water. The structural elements are pushed by the impact of water flow and subsequently “sunk” in the created pool.

5. Location, structure, and construction of riffles should be carefully thought out and designed. It should be a result of collaborative work of hydrologic engineering specialists, geomorphologists and ecologists, in order to create more durable and effective hydraulic structures.
