ANALYSIS OF EROSION CONTROL CONSTRUCTIONS EFFECTIVENESS. THE CASE OF A ROAD GULLY IN WIELKOPOLE (LUBLIN UPLAND)

Andrzej Mazur¹, Radomir Obroślak¹, Kamil Nieścioruk¹,
Żanna Król¹, Justyna Gabryszuk¹, Roman Rybicki¹

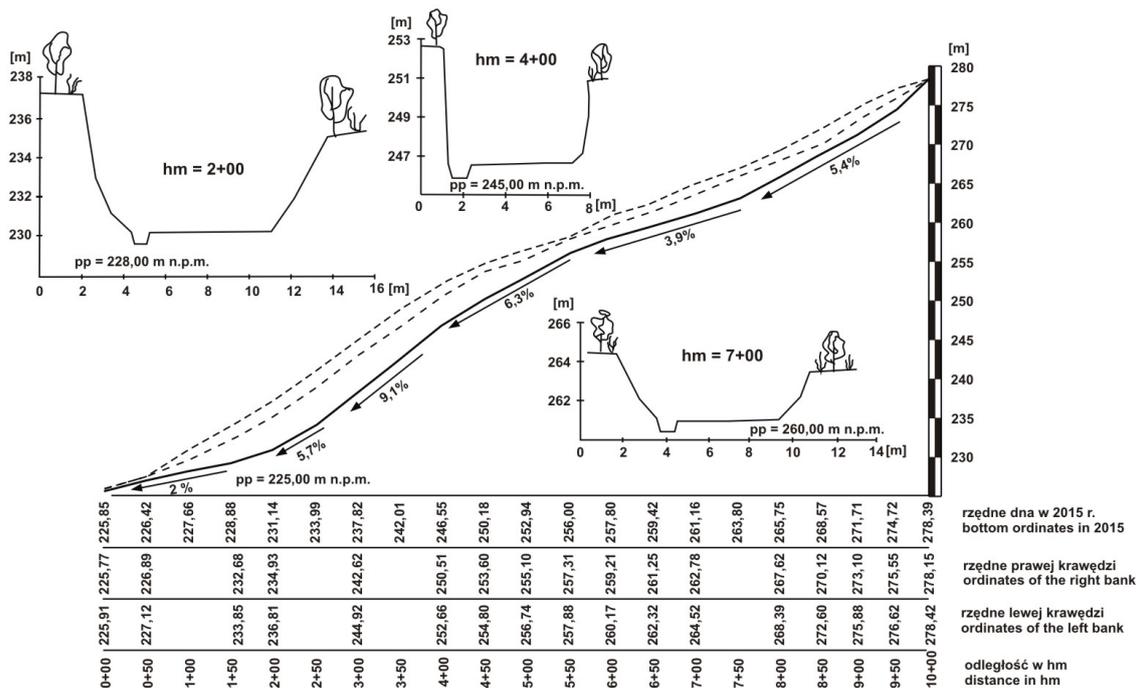
The analysed gully (fig. 1) developed on loess-based soils on a south-east slope, where a rural road led to fields [Mazur 2008]. Its area reaches 1.8 ha, it is 900 meters long and 6 to 14 meters deep, with the left slope being 1 to 2 meters higher than the right one. Both slopes are steep, with a gradient of 1:0.5 in a lower part, 1:1.5 in

an upper and vertical in most of a middle part. The width of a gully bottom is from 5 in a lower part to 7 meters in a middle part with an average of 5.5 meters. The maximum gradient of the bottom is 9.1% with an average equal to 5.3%. In the lower part, on a section of about 3 hm, the gully direction is coincident with a slope direction, while in an upper part it is oblique. It resulted in a 3.5 ha catchment area in an upper part of the gully. The water from a catchment runs-off on a left slope of the gully into a middle and a lower part of it. The run-offs caused by a spring thaw or storm rainfalls activated erosion processes in the gully, resulting in high loss [Mazur 2008]. These were reasons for the commune of Gorzów authorities to protect the gully. Works were done during 2009–2010 and a concrete covering of a field road at the bottom of the gully was laid. Its thickness is about 20 cm, width – 4 m and length reaches 800 meters. The bottom part of a right slope was additionally secured with a concrete openwork plates while on the left slope there was a channel constructed, made of concrete prefabricated trapezium-shaped elements and designed for directing the run-off water out of the gully.

Figure 1. A longitudinal profile and cross-sections of the road gully

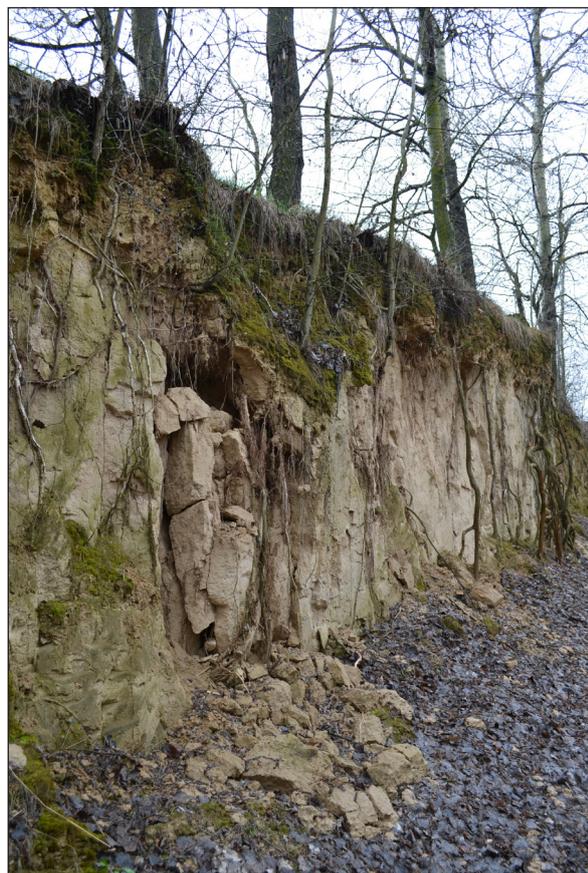
Figure 2. Loess falling off vertical slopes of the gully

Earthmass movements were particularly active on steep slopes of the gully. Solifluction were also noted there, especially on parts with no plants. The influence of this factor on relief forming is small because of a limited occurrence of the phenomenon. A falling off is often seen form of erosion on vertical, non-covered with vegetation slopes in a lower and a middle part of the gully (Fig. 2). The total area of occurrence of this process was about 900 square metres of slopes. As the result, sediment cones of total volume of about 22 cubic metres developed at the foot of the slope. The creep processes were shaping the gully in its upper part too, what was accompanied by movements of earthmass with shrubs and herbaceous plants. They formed numerous shallow slump up to 0.4 metres deep and of total area of 12 square metres.

To prevent development of the gully and protect the road no. 842 and its draining system against colmatation, left slope of the gully has to have water inflow cut off or the water has to be directed to the gully's bottom with a hardened channel. A solution of this kind should eliminate under-surface erosion seen at the foot of the left slope. Trees by the brink of the gully should be removed as well, as they increase loess fragmentation with their weight and their roots penetrating the rock. As a next step, steep and vertical slopes should be transformed to have a gradient of 1:1 and should be technically and biologically protected to eliminate earthmass movements.
