Assessment of Changes in Channel Morphology in a Mountain River Regulated Using Grade Control Structures

Joanna Korpak¹

¹ Faculty of Environmental and Power Engineering, Cracow University of Technology, Warszawska 24, 31-155 Cracow, Poland

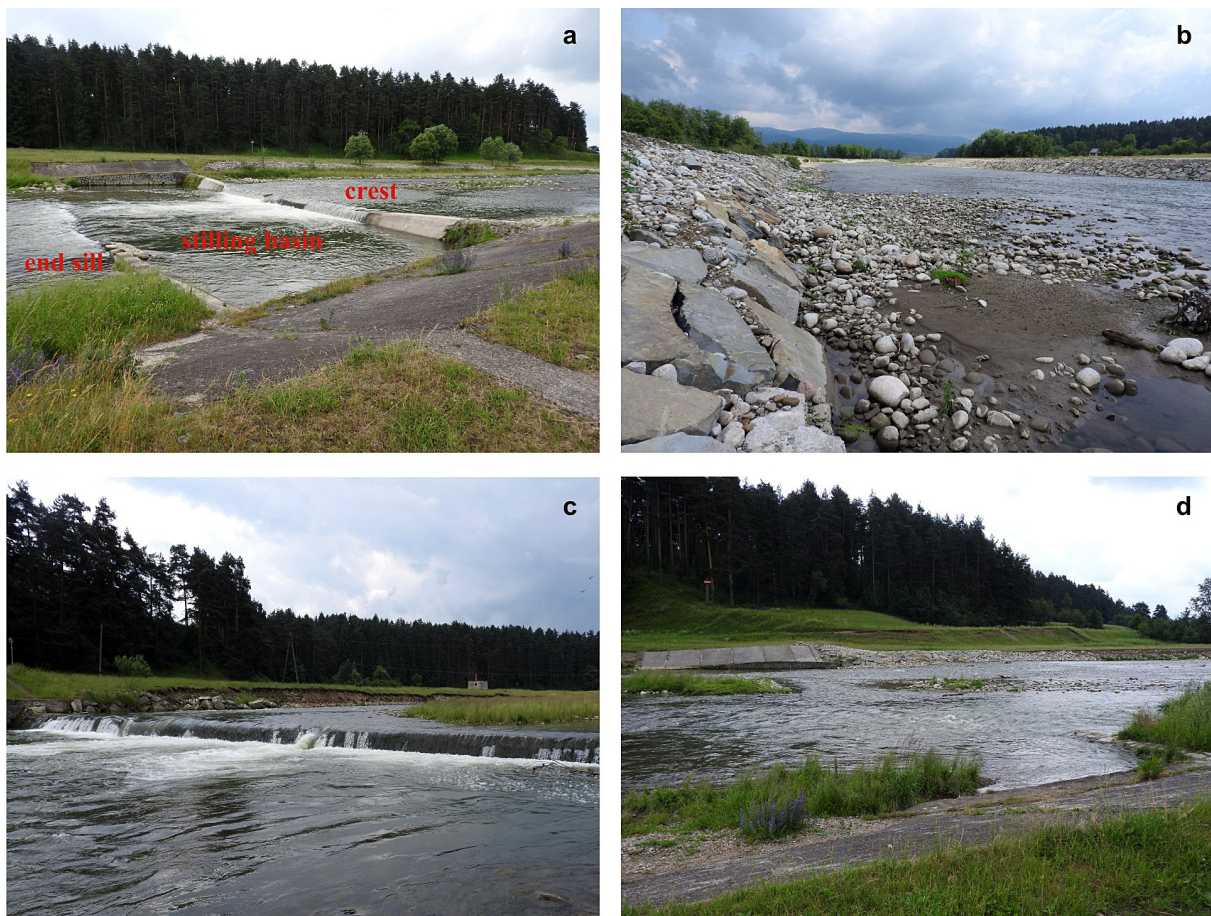
with GCSs. Major changes did occur in the long section 6–3, where riverbanks were newly created and reinforced (Photo 1b). Denudation forms present in this section were formed artificially and contained material from the riverbank readjustment process.

Photo 1. Channel section with grade control structures on the Biały Dunajec in the city of Nowy Targ: a – GCS, b – recreated and newly reinforced riverbank, c – damaged bank reinforcement and partly eroded GCS's crest, d – GCS covered with debris

in the course of regulation work. In many places the reinforcements were damaged and partly washed away (Photo 1c). In sections 10–9, 8–6, and 2–1 high bars covered with vegetation were noted along the left bank of the river. They were higher than the remaining bars, but lower than the floodplain. Cutbanks or reinforcements were found on opposing banks. Such a situation proves downcutting and a tendency of the channel to lateral migration.

GCS no. 9 was fully covered with debris. Its crest included a central bar (Photo 1d). Most GCSs had partly deteriorated crests and end sills downstream of stilling basins (Photo 1c).

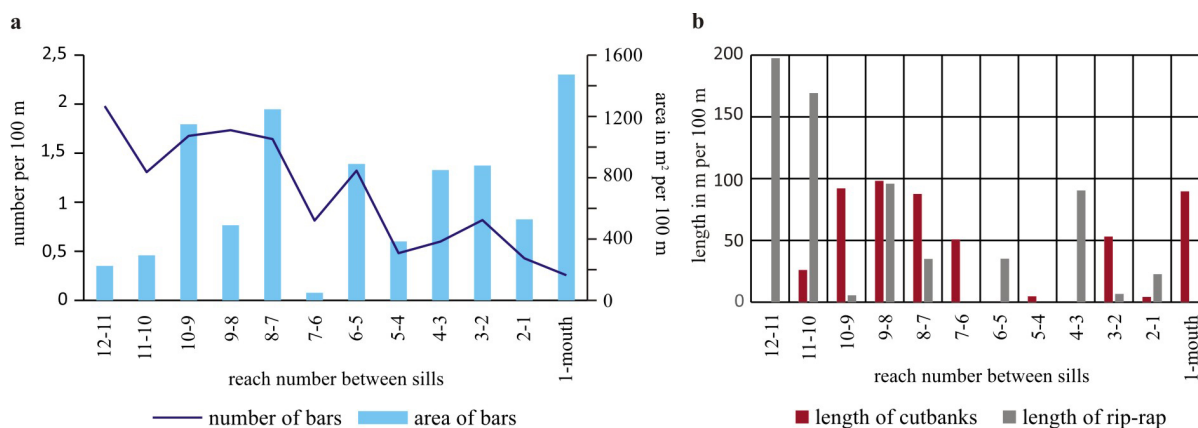
Figure 3. Fluvial forms and riverbank reinforcements recorded in the course of field surveys in 2019: a – number and area of bars, b – length of cutbanks and new bank reinforcements; all values are expressed per 100 m of channel length

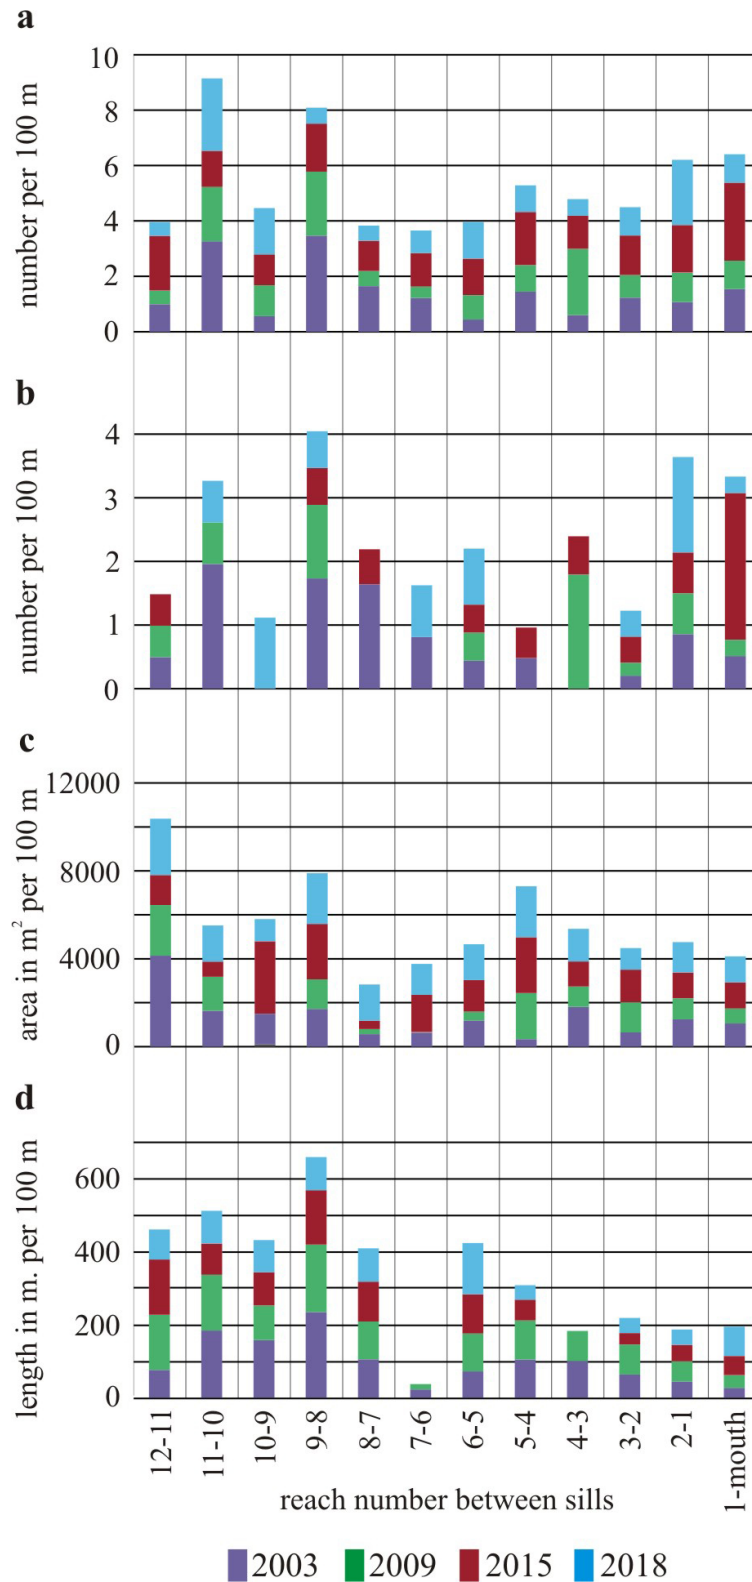
Research has shown that the largest number of bars formed in river sections 11–10 and 9–8 as well as between GCS no. 2 and the mouth of the river. The largest area occupied by bars was noted in sections 12–11 and 5–4 (Figures 4a, c). The role of deposition was found to be least important in sections 8 to 5. The largest number of central bars, which suggests braiding tendency, were observed in section 9–8 (Figure 4b). In addition, channel sections 11–10 as well as those between GCS no. 2 and the mouth of the river were characterized by the presence of a large number of central bars. The number of cutbanks tended to decrease towards the mouth of the river (Figure 4d) – their largest number was observed in section 9–8, while large declines were observed downstream of GCS no. 4. Section 7–6 was affected by some lateral erosion, as observed on photographs up to 2009, with no undercuts noted on photographs from 2015 and 2018. Narrow lateral bars covered with vegetation were identified, on all the studied photos, along the left bank in channel sections 8–6 and 2–1. Similar forms were also found along the left bank in section 10–9 in 2015 and 2018. Vegetated central bars were also observed in section 4–3 in 2009 and 2015. The presence of these forms implies the presence of downcutting.

Figure 4. Fluvial forms observed on aerial photos from 2003, 2009, 2015, and 2018: a – number of bars, b – number of central bars, c – area of bars, d – length of cutbanks; all values are expressed per 100 m of channel length

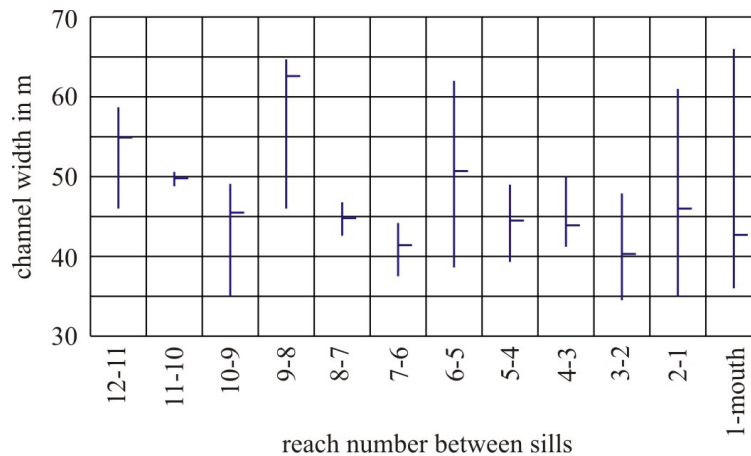
The initially uniform width of the regulated channel became highly variable (Figure 5). The mean width of the channel was 45.7 meters, according to an orthophotomap from 2018, ranging from 41.4 m in section 3–2 to 62.6 m in section 9–8 (section with largest number of undercuts). The largest differences in width were noted for the section from GCS no. 2 to the mouth of the river as well as sections 6–5 and 9–8. The most highly uniform channel width was observed for sections 11–10 and 8–6. In the first case, the cause of this was riverbank reinforcements. In the second case, it was the occurrence of high, vegetated lateral bars narrowing the profile of the river channel.

Figure 5. Width of river channel in sections between each GCS, measured on an orthophotomap from 2018

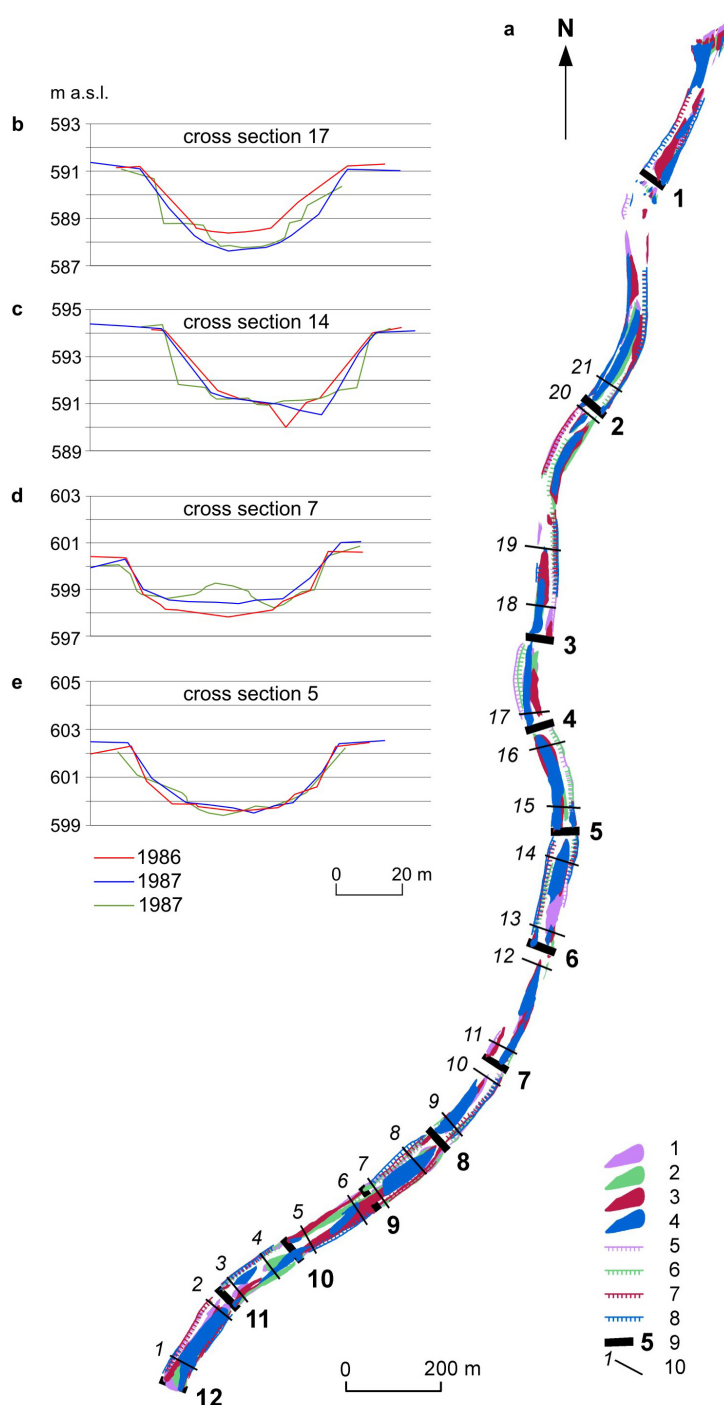
A side-by-side comparison of bars and cutbanks from all the aerial photos revealed main areas of deposition and lateral erosion that functioned during the study period (Figure 6a). It turns out that the location of the largest bars and cutbanks is similar from year to year. This does not apply to sections 12 to 8, where bars formed at multiple locations and both riverbanks were undercut. In subsequent sections one may easily observe a tendency of concave riverbank erosion as well as deposition under convex riverbanks. In the case of straight sections, such as section 6–5, central bars form and both riverbanks become eroded. Hence, the right bank of section 8–7 is eroded, left bank of section 7–6 is eroded (short segment downstream of GCS no. 7), right bank of section 5–4, left bank of section 4–3, first the right bank and then the left bank of section 3–2, and finally right bank of section 2–1. In the section between GCS no. 1 and the mouth, both riverbanks are eroded, but bars form mainly close to the right bank and right at the mouth of the studied river.

This prompts the following question: What is the scale of observed changes over the course of the entire study period? The answer to this question is provided by an analysis of cross sections for the years 1986 (immediately after regulation work), 1987 (after first major flood), and 2019 (after 33 years of the functioning of GCSs) made for the same locations along the studied channel (Figure 6). It is important to remember that measurements collected in 2019 were performed right after repair work on the channel of section 6–3 (Figure 6c).

erosion was noted in section 4–3. Its increase in channel depth in the years 1986–1987 reached a maximum of 73 cm (Figure 6b). However, in later years some deposition was observed. The largest increase in channel depth in each studied year is noted at the same location – most frequently under one riverbank. The largest deposition occurs in section 9–8, where the height of the channel bed increased by an average of 41 cm in the years 1986–1987; however, a small decrease has been observed in 2019 (Figure 6d). Vertical stability was observed in sections 10–9 and 8–6 (Figure 6e). Analysis of horizontal changes associated with lateral erosion showed that the displacement of a riverbank, triggered by a single flood event, may be as large as approximately 10 meters. However, many repair works have been performed in the years since, and the location of riverbanks in the studied channel is now similar to that in 1986. The maximum shift of the channel bank is approximately 11 m above GCS no. 8.

Figure 6. The changes of river channel morphology: a – location of bars and cutbanks in the years 2003, 2009, 2015 and 2018: 1–4 – bars present in the following years: 2003, 2009, 2015, 2018, 5–8 – cutbanks present in the following years: 2003, 2009, 2015, 2018, 9 – GCSs with their numbers, 10 – cross sections with their numbers; b-e – cross sections of the channel in years 1986, 1987 and 2019: b – in the section with downcutting, c – in the section recreated and newly reinforced in 2019, d – in the section with deposition, e – in the stable section
