Estimation of Organic Soils Subsidence in the Vicinity of Hydraulic Structures – Case Study of a Subirrigation System in Central Poland

Andrzej Brandyk^{1*}, Ryszard Oleszczuk², Janusz Urbański³

Keywords: organic soils, subsidence, sub-irrigation system, hydraulic structures, technical parameters, culverts and culvert-gates.

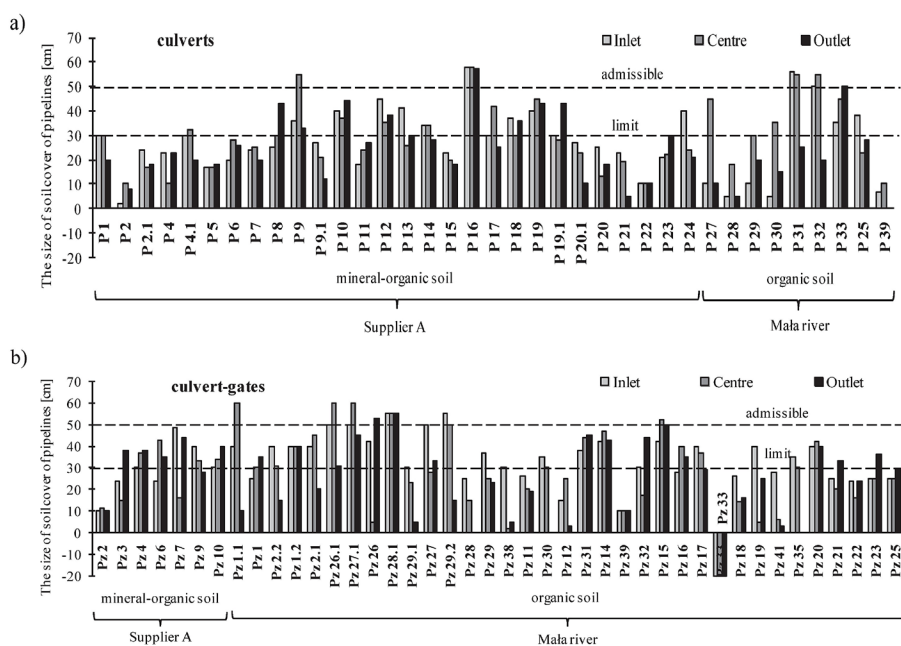
Fig. 4. a Covering thickness of the culverts' pipelines; **b** Covering thickness of the culvert-gates' pipelines

It was found that the majority of the culverts, located within the research area, were not covered by the required soil thickness, equal to 0.6 m. Except for the culvert p16, none of them reached the admissible value (50 cm), and the following culverts: p9, p10, p12, p14, p18, p19, p19.1, p33 (Figure 4a) did not exceed the limit value (30 cm) at their whole length (6.0 m). Other pipelines were characterized by considerably smaller covering thickness (below 30 cm). Secondly, the case of the culvert-gate pipelines revealed that only one, i.e. pz28.2, was covered by proper soil thickness of 60 cm (admissible value) at its whole length. The existing covering of the pipelines of the following culvert-gates: pz4, pz9, pz1.2, pz26.1, pz27.1, pz27, pz31, pz14, pz15, pz16, pz17 and pz20 did not exceed the limit value (that is 30 cm or more). Particular attention was paid to the structure pz33, the pipeline of which was subject to the exposure of about 20 cm above ground, as an effect of surrounding terrain subsidence

(Figure 4b). The lowest thickness of the covering of pipeline elements (inlet, the middle part, and the outlet) of the culverts was found in the final reach of supplier A (Figure 4a), while for the culvert-gates, a similar case was evident for the middle reach of the Mała River (Figure 4b).

(Figure 4b) meaning that within the period of 43 years (1971–2014) the subsidence rate equaled about 80 cm, and the yearly average rate at the whole length of that pipeline reached approximately 1.86 cm/year.

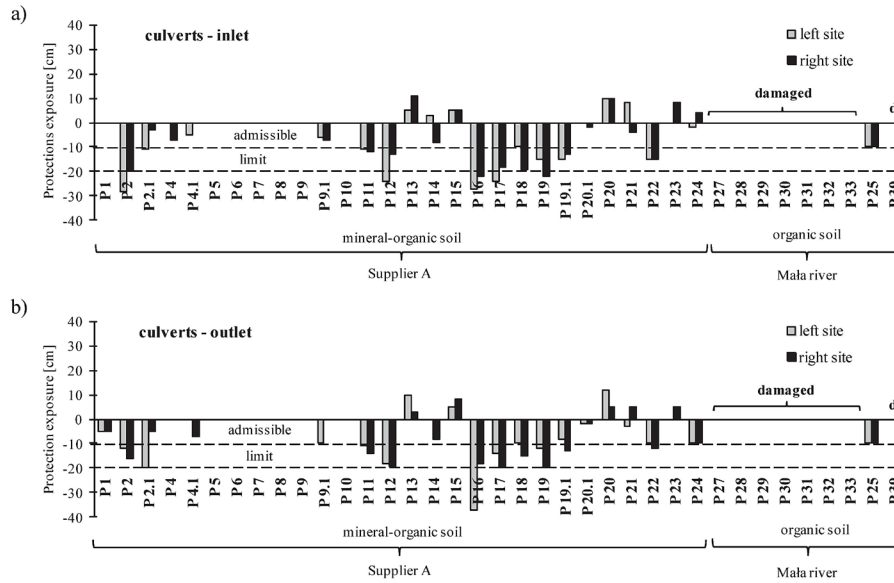
Fig. 5. a Culvert protections exposure at the inlet; b Culvert protections exposure at the outlet

Figure 5 illustrates the measured exposure height values of the culvert protections (negative values) and possible covering (positive values). The soil surface elevation in the vicinity of the protections on their left and right side seems similar at the inlet as well as the outlet part (Figure 5a,b). It was noted for the culverts: p5, p6, p7, p8, p9 and p10 that the soil surface level in their surroundings was equal to their upper edge (0 value on the graph) which stands for the preservation of the designed subsidence range in reference to the terrain altitude. This is due to the fact that part of the subirrigation system (located along supplier A), which contains the culverts, is underlain by mineral-organic soils of inconsiderable subsidence. However, for a couple of the analyzed protections, both at the inlet and the outlet, the ground level overtops their upper edge (positive values in Figure 5). This suggests the overgrowing of their elements with turf since they have been surrounded by the lands used as meadows. On the other hand, the culverts located along the Mała river showed considerable damage of the protections, most likely due to their exposure after a progressing subsidence of the organic soils found at that location (Figure 5). The

excessive inclination and cracks of those culverts were noted.

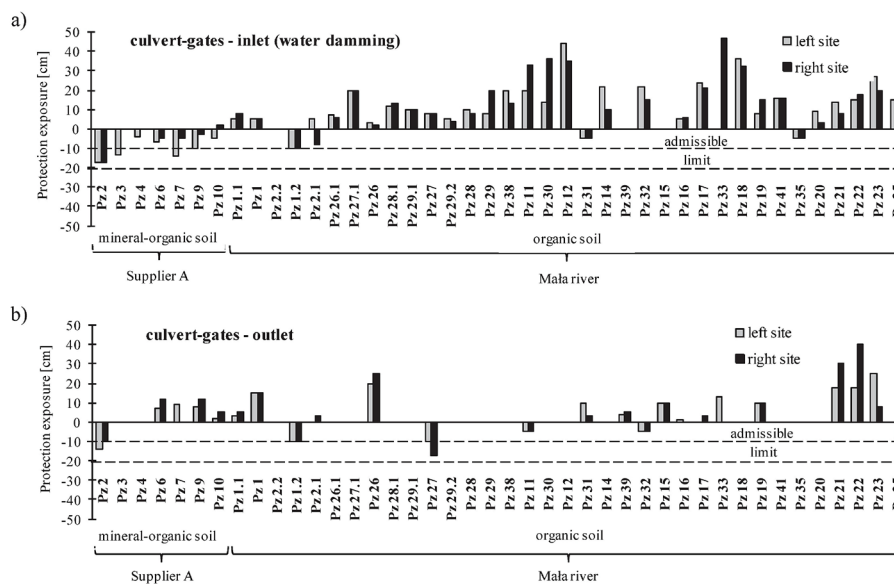
Fig. 6. a Culvert-gate protections exposure at the inlet; b Culvert-gate protections exposure at the outlet

Considering the status of culvert-gates, the elevations of the upper edge of their protections were found to be rather variable at the inlet and outlet part (Figure 6a and b). It is worth stressing that at the inlet part, which underwent water damming for subirrigation in the past, the protections were significantly overgrown by turf and a smaller number of damaged protections

occurred (2 cases). At the outlet sections (lower water level), the overgrowing degree became definitely smaller, while the damage score was visibly higher (Figure 6b). Those differences may be explained by the fact that water damming at the inlet of culvert-gates resulted in a higher soil moisture content that contributed to a lower subsidence rate. At the same time, such conditions provided for the vegetation development in the neighborhood of the structures, likely to make

the protections overgrown (Figure 6a). In the case of the protections of the outlet part (lower water) their significant exposure was revealed, as well as serious damage and no turf overgrowth (Figure 6b).
