Assessment of Corrosion Phenomena of Hydromechanical Fittings and Elements of Excavation Support Under the Conditions of Active Mine Exploitation

Małgorzata Ciosmak^{1*}, Tomasz Parzniewski²

¹ Lublin University of Technology, ul. Nadbystrzycka 38D, 20-618 Lublin, Poland

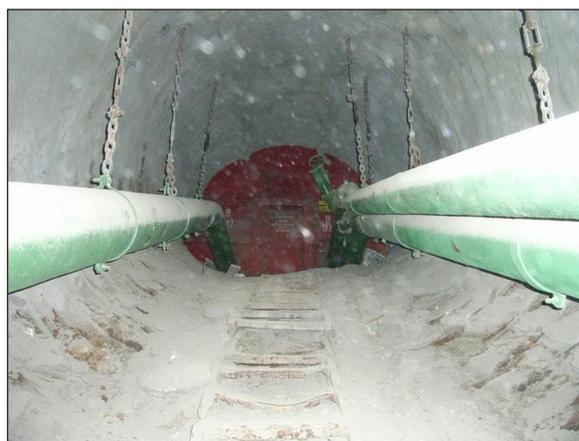
of the drainage operation, which is about 40 years. Ensuring the continuity of drainage operation requires periodic inspections, including of the wall thickness, which is exposed to external and internal corrosion. Steel flanged pipes with loose or fixed flange adapted to a pressure of 4.0 MPa, are manufactured in accordance with PN-EN1092-1. Pipelines of the main drainage, installed vertically, with length of several hundred meters, must withstand pressures higher than 10 MPa. The materials used for drainage components (pipes and control fittings) are S235JRH, S355J2H, P265GH, P235TR1, P235TR2, P355TR1, P355TR2, L235, L275, L355, E235+N, St370, St44.0, St52.0. Both pipes and fittings (dewatering pumps) have anti-corrosion protection by galvanization of factory-made components, as well as special paint, and in the case of pipelines with flanged connections, PE polyethylene inserts. As a general rule, water-guiding pipelines and control fittings are manufactured in a double-sided galvanized version.

Fig. 4. DN400 main drainage pipelines and mine excavations with visible sprayed concrete

The methods of strengthening the support of corridor excavations by spraying concrete (shotcrete), which are favorable due to strength parameters, require developing an effective method of revising the space under the concrete layer due to the possibility of hidden corrosion phenomena.

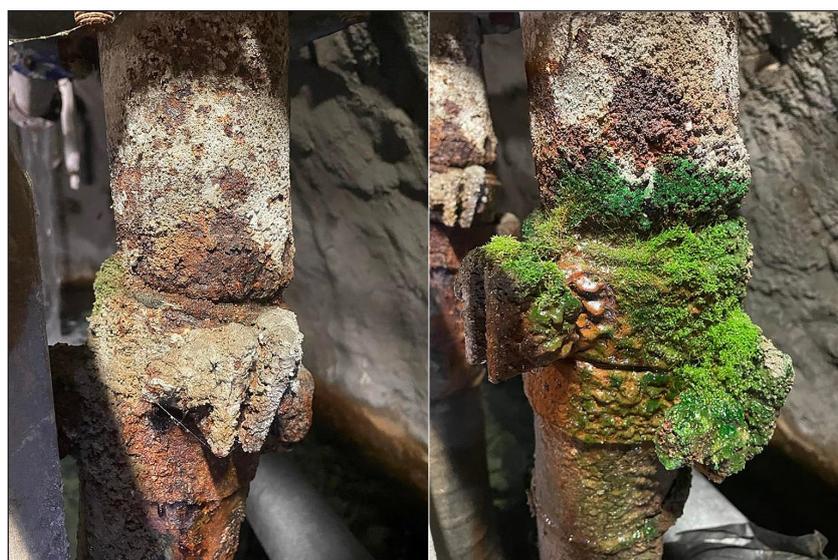
On elements of drainage pipelines from the drainage of Jurassic strata (Shaft 1.5, depth 640 m), mosses develop in places with a high accumulation of corrosion products. (Fig. 6) Their presence may indicate a decreasing pH value, which intensifies the corrosion phenomenon when in contact with bare material. The water conducted in the drainage pipeline has a pH = 8.1–8.3. The existence of moss on the outer surfaces indicates a pH <7.0. In addition, the constant presence of white light allows these plants to thrive and reproduce.

Fig. 6. Flora developing on corrosion products under 24h white light illumination. Level 640, drainage of Jurassic formations. (Photo: M. Ciosmak)

In areas of high humidity, such as water walkways, flora develops on corrosion products in the presence of white light, including bacteria, algae and moss. These are isolated cases, but the metabolic products of these organisms strongly contribute to the destruction of materials, including corrosion protection.
