WATER MANAGEMENT PROBLEMS AT THE BUKÓWKA DRINKING WATER RESERVOIR'S CROSS-BORDER BASIN AREA IN TERMS OF ITS ESTABLISHED FUNCTIONS

Mirosław Wiatkowski¹, Czesława Rosik-Dulewska²

The paper covers the analysis of water management problems in the cross-border reservoir basin of Bukówka, located at the Bóbr river, at 271+540 km of its course, below the Czech-Polish border, in Dolnośląskie Voivodeship. The problems of water management in the context of the reservoir's functions have been analyzed; these are: flood control, the provision of water during low water level periods for the Water Treatment Plant in Marciszów, the provision of drinking water for the city of Wałbrzych as well as the provision of proper flow in the Bóbr river bed downstream from the reservoir. Due to its localization right below the border with the Czech Republic, the reservoir is exposed to a number of problems. The study has found that the main problems of water management in the basin area included unsatisfactory state of water and wastewater management in the basin, unsatisfactory state of the surface water quality in the basin area of the reservoir, poor condition of streams and drainage ditches, improper a

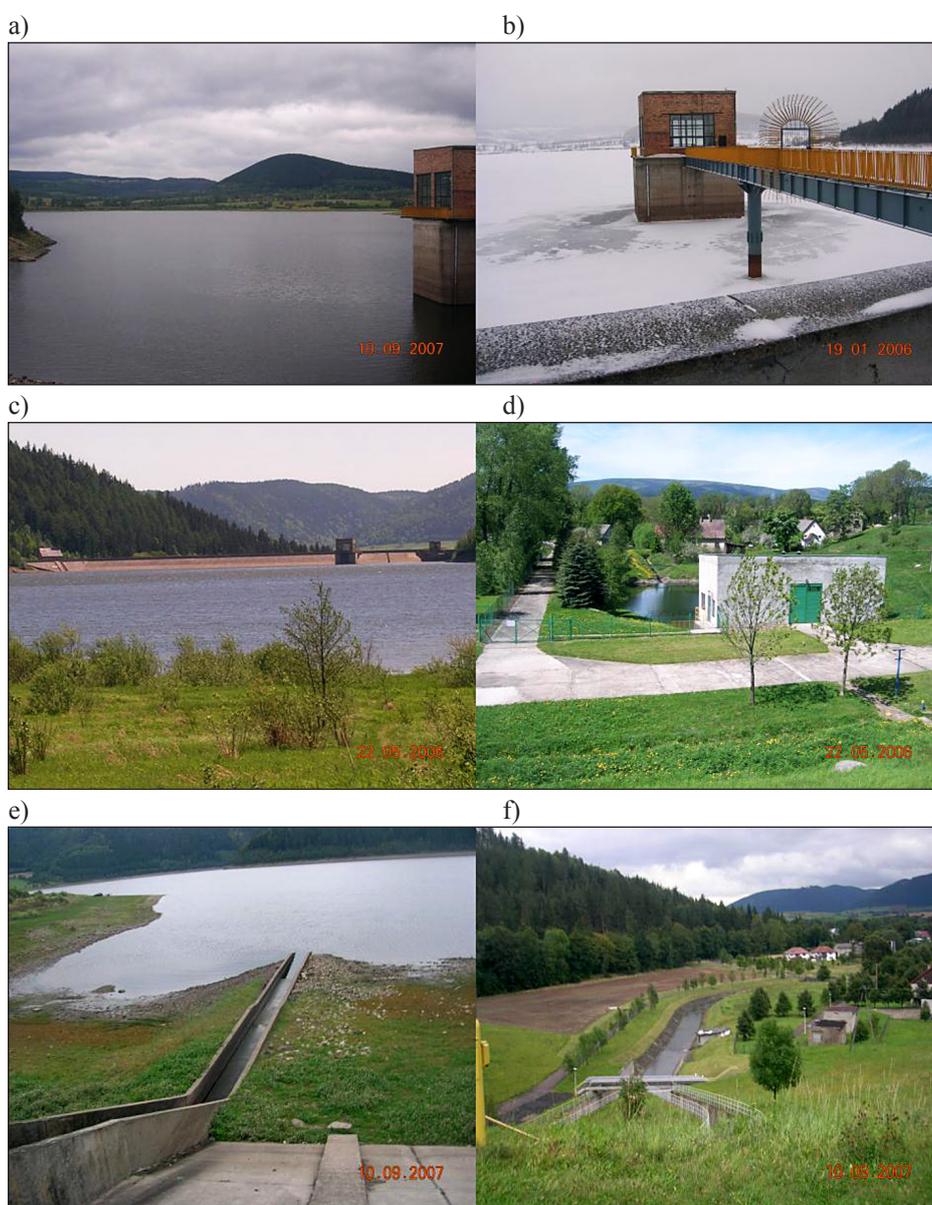
The Bukówka water reservoir is located on the Bóbr river at 271+540 km (left-hand tributary of the Odra river), in the Lubawka municipality, Kamienna district. The Bukówka reservoir is one of the highest above-sea-level dam reservoirs in Poland. Its main components are the reservoir's bowl (Figure 1a, b): an earth dam with drain devices. The central dam is located between two mountains: Zameczek and Zadzierna (Figure 1c). Moreover, the reservoir consists of bottom release, surface spillway, intake of tap water for Wałbrzych Water and Sewage Enterprise, which is currently not in operation, hydroelectric power plant and side dam Miszkowice (Figure 1d, e). Almost the

Figure 1. The Bukówka reservoir's bowl (a, b), ground dam (c), the Miszkowice reservoir (d), the side dam Miszkowice and the polder outflow (s), The Bóbr riverbed from the Bukówka reservoir (f)

entire reservoir is limited by natural banks, except for the front and side dams (Figure 1f). The side dam is located in the Miskowice village area in the western part of the reservoir. The function of the side dam is to protect the Miskowice village from the reservoir's backflow. Since Miskowice polder is not capable of performing gravitational drainage, drainage pumping is done using three pumps. Water management in the polder is automated [Manual 2007]. The parameters of the tank: 12.01 million m³ and 167.0 ha at a normal level and 16.790 million m³ and 199.0 ha at maximum flood level [Operat 2007].

The outflow from the reservoir is done through bottom release and surface spillway (Figure 1f). On the wall of the bottom release a gauge

patch is placed (Figure 1a, b), and also the reservoir is equipped with a limnigraph. An operator discharges water from a modern control room located in the tower of inflow and outflow (Figure 1a, b). The dam is also equipped with piezometers and a drainage trench located on the air side of the dam.

- The unsatisfactory state of water and waste water management in the catchment area (illegal channeling of sewage into the river Złotna and Paprotki ditch) (Figure 1),
- The unsatisfactory state of surface water quality in the basin of the reservoir (Figure 1),
- The poor condition of streams and drainage ditches (Figure 2),
- Improper arrangement of arable land and large slopes (which cause a rapid outflow of water and pollutants from the reservoir) (Figure 3a).
- A lack of water monitoring stations on the reservoir's tributaries (Bóbr, Opawa, Złotna, Bachorzyna, Paprotki). Currently, the gauge patch is installed downstream from the reservoir. This means that the reservoir does not have any hydrological protection.

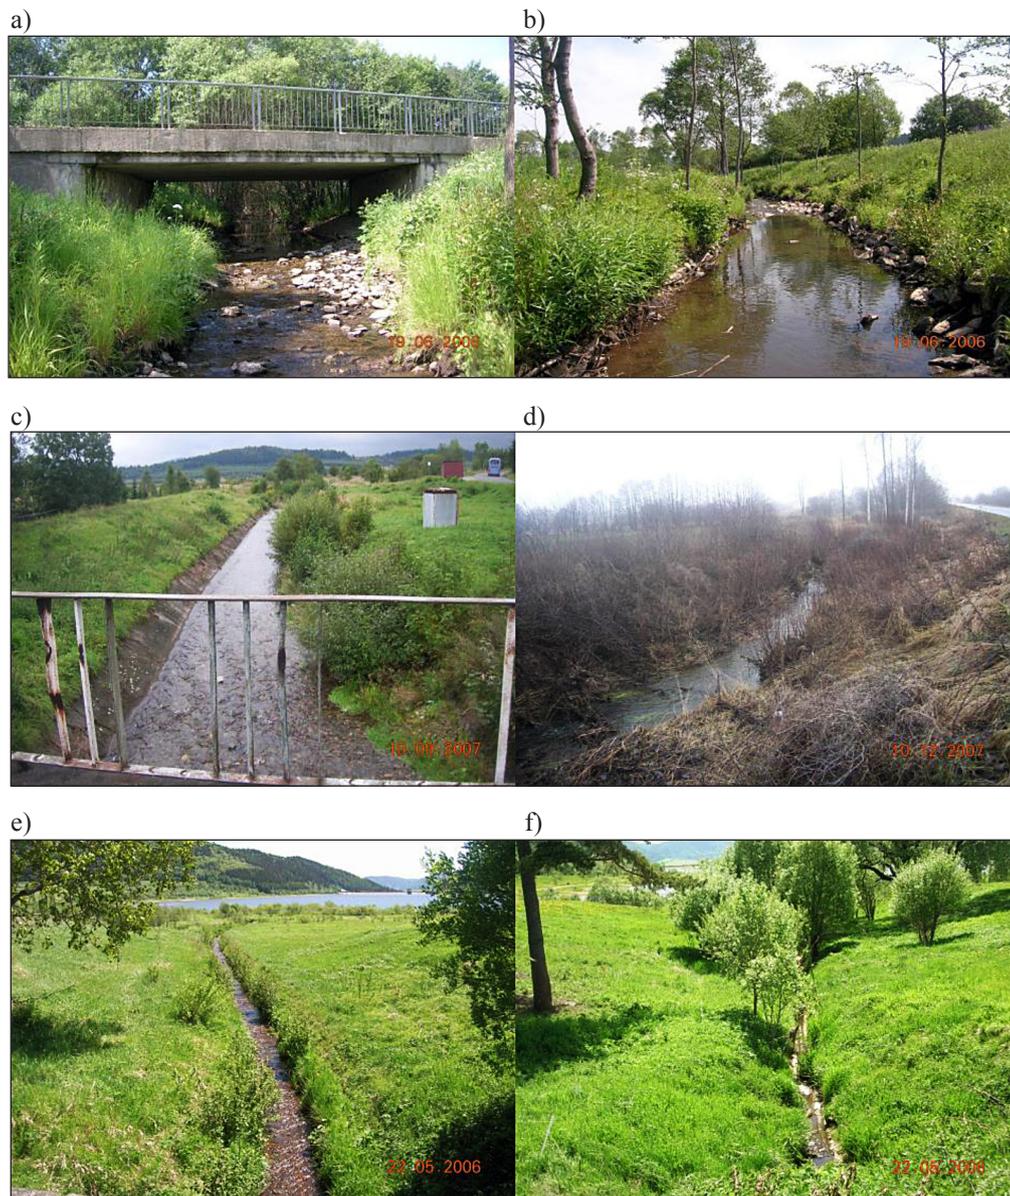
Figure 2. The Bukówka reservoir's tributaries: Bóbr riverbed (a, b), Złotna (c), Opawa (d), Bachorzyna (e), Paprotki (f)

meters, then more than four kilometers in Poland, and flows into the Bukówka reservoir [Ocena 2007; Report 2005]. The longitudinal slope of the Bukówka reservoir's basin is approx. 8.8%. The basin area is used for agriculture (approx. 50%) and covered with woods (approx. 45%). There is also a visible slope of the basin, mostly from west to east, and in the southern part of the basin from south west to north east [Operat 2007]. The Bukówka reservoir is a recipient of several watercourses (Figure 2): rivers Bóbr, Złotna, Opawa and Bachorzyna; it also receives waters from several drainage ditches: Paprotki and pumped water from the Miskowice polder.

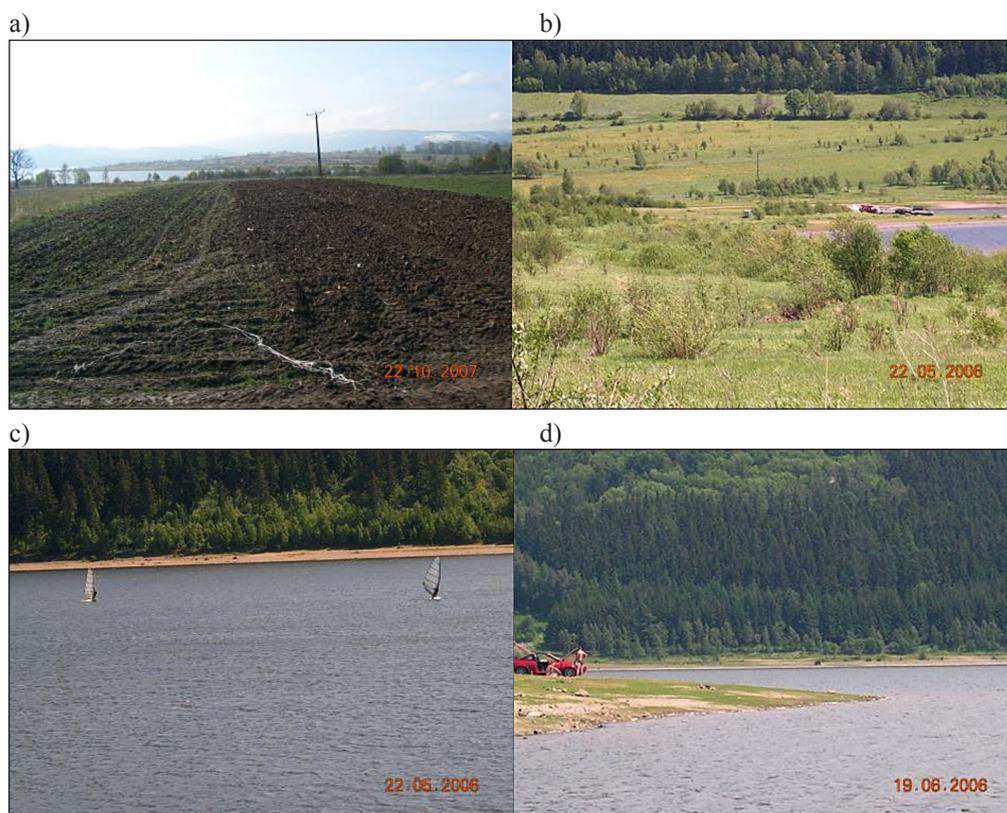
Figure 3. The usage of the Bukówka reservoir

During the study period the Bukówka reservoir was also used by anglers. According to the rules any other possibility of recreational use of the reservoir during the study period was not allowed. However, as it was noted, the reservoir was used by the public for recreational purposes and bathing (Figure 3b, c, d). There is no doubt that the Bukówka reservoir due to its large area of various coastlines, perfectly blended into the surrounding mountains, is a recreational and landscape attraction. Therefore, attempts were made to obtain permission for recreational use of the reservoir. It is worth noting, however, that in this case it is necessary to perform the assessment of the possibilities of adapting it for recreational purposes. The most important is the tourism capacity, not only because of the perfect leisure condi-
