ANALYSIS OF ECONOMIC AND ENVIRONMENTAL EFFECTS OF LAND CONSOLIDATION ON THE EXAMPLE OF HUCISKO VILLAGE

Przemysław Leń¹, Żanna Król¹

¹ Department of Environmental Engineering and Geodesy, University of Life Sciences in Lublin, Leszczyńskiego Str. 7, 20-069 Lublin, Poland, e-mail: przemyslaw.len@up.lublin.pl, zannakrol.up@o2.pl

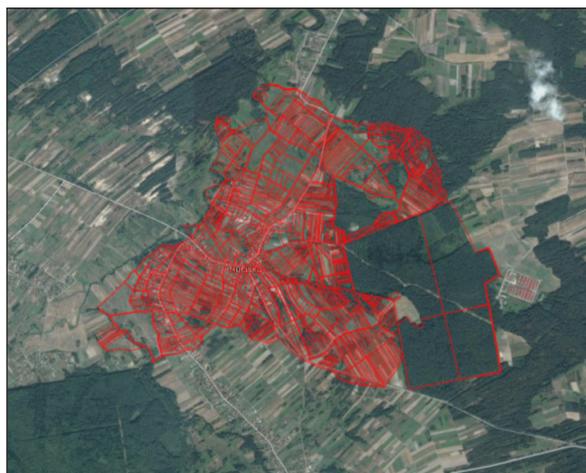
Fig. 1. The object prior to the consolidation, presented on the basis of an orthophotomap

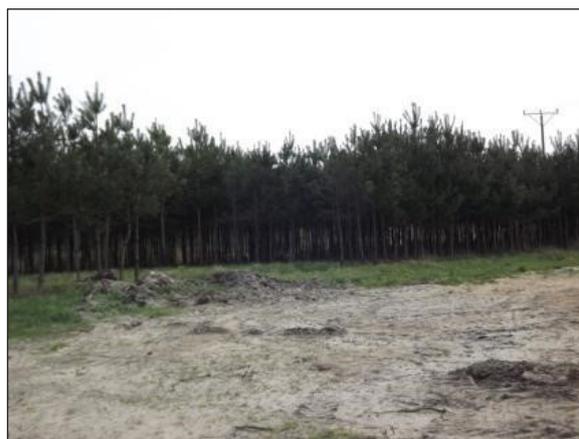
Photo 1. Example of coniferous forest in Photo 2

The forest areas and the tree- and bush-covered lands in the area of the village under study are illustrated in the photographs below.

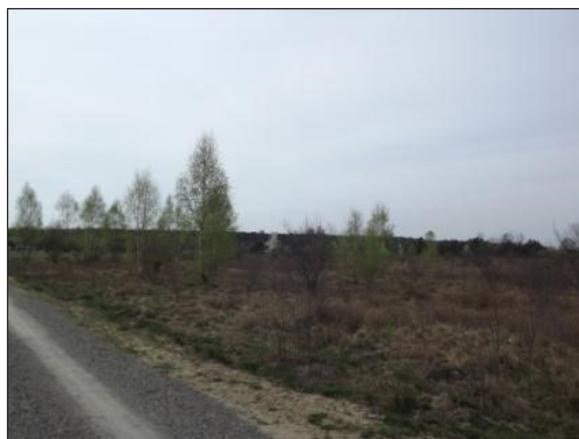
Photo 2. Example of mid-field bush- and tree- the area covered by the consolidation covered lands occurring in the area covered by the consolidation

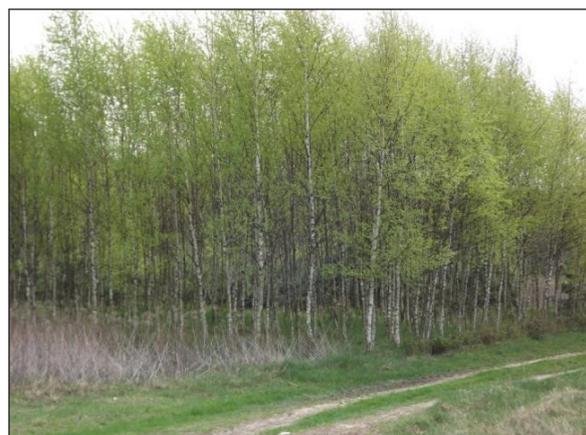
Photo 5. Example of peatbog overgrown with birch

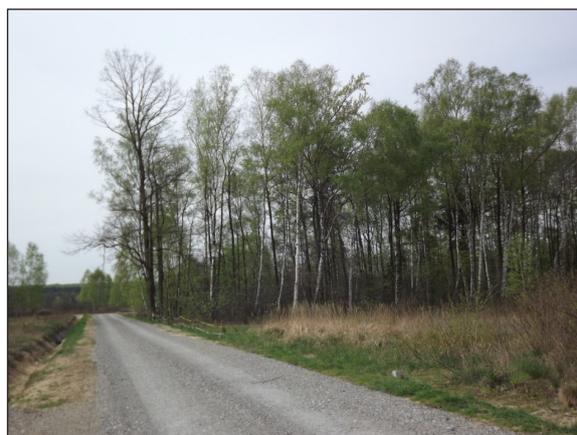
Photo 6. Example of peatbog overgrown with birch

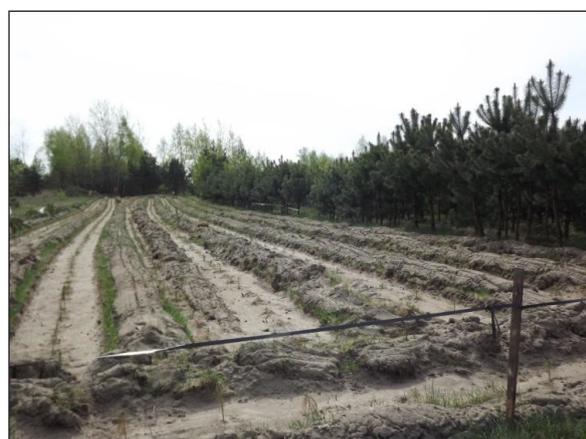
Photo 7. Example of area afforested in the framework of post-consolidation development

1. Increase in the areas of lands for development based on the existing settlement system.
2. 3.10 ha of farmland were set apart for reclamation by afforestation.

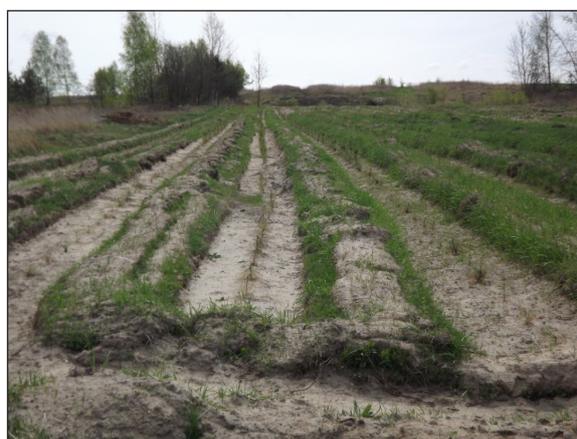
Photo 8. Example of area afforested in the framework of post-consolidation development

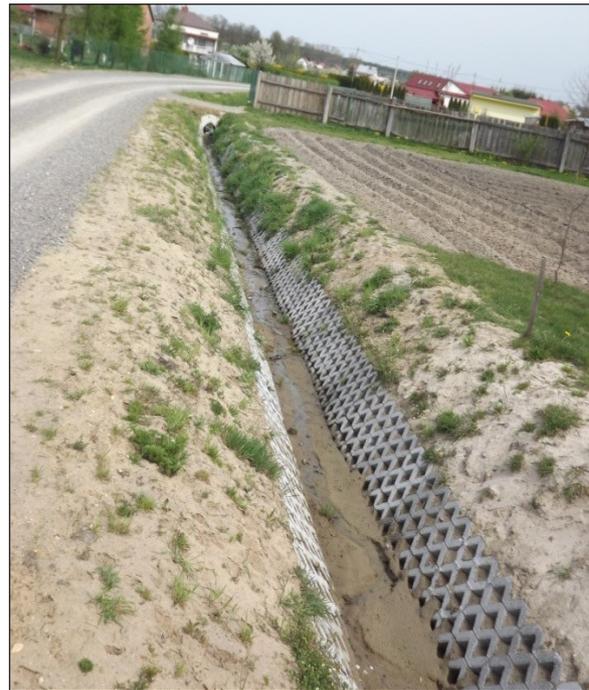
Photo 9. Example of renovated melioration ditch in the area of the consolidation

As far as elements of water management are concerned, in the process of land consolidation existing culverts on detail melioration ditches were modernised, and new culverts were built in areas with difficult access to the public roads due to the existing network of melioration ditches. That modernisation caused an improvement of water relations, which had a positive effect on the water-air relations in the soil.

6. Access was designed to each of the resultant post-consolidation plots.
7. Reconstruction and renovation of melioration ditches, which will bring the meadows, currently waterlogged, to a state of usability. 7 culverts were built on the melioration ditches, in the belts of the newly designed roads. 80% of the melioration infrastructure required reconstruction and conservation.

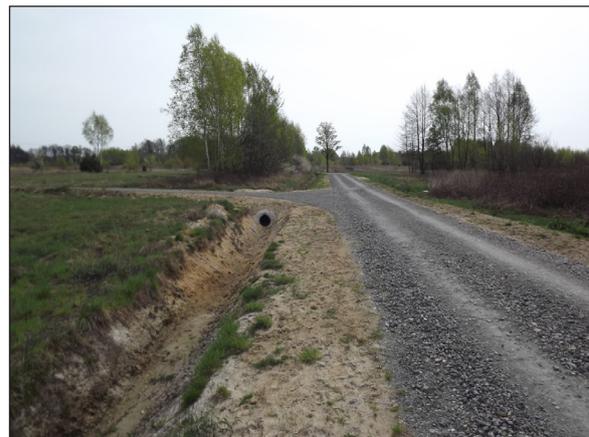
Photo 10. Example of new culvert built in the area of the consolidation

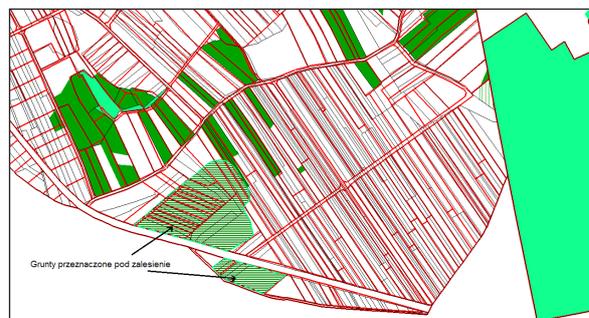
Fig. 3. Fragment of map of modified farmland [on the basis of assumptions to the land consolidation project]

5. Improvement of land layout in farms and reduction of the number of plots in a farm. The total number of plots was decreased from 2355 to 1568. Also the shapes of the farmland plots were changed.
