CULTURAL LANDSCAPE, FLOODS AND REMOTE SENSING

The dynamics of the cultural landscape is associated with the penetration of people into the natural landscape, the settling and adaptation to the needs of the society and its development. Climate creates the decisive influence, specifically the form of extremely high rainfall causing flooding. Adverse impact on the cultural agricultural landscape is mainly the submersion time. This time depends on the configuration of the terrain, its disposition and the existing drainage ditches in the area, ensuring the drainage of the flood to the recipients. Long-lasting floods have stipulated taking measures for the protection of the area from flooding by building dikes and drainage of the flood from the area. Identifying the extent of extreme floods and zones of permanent waterlogging is currently provided by modern technology which allows recording satellite images in different spectral bands. Within the basic distinguishing signs mainly accruing is used and it is possible to track changes of the extent of flooded areas and thus identify problem areas insufficiently protected against long-term flooding. Consequently, it is possible to solve the

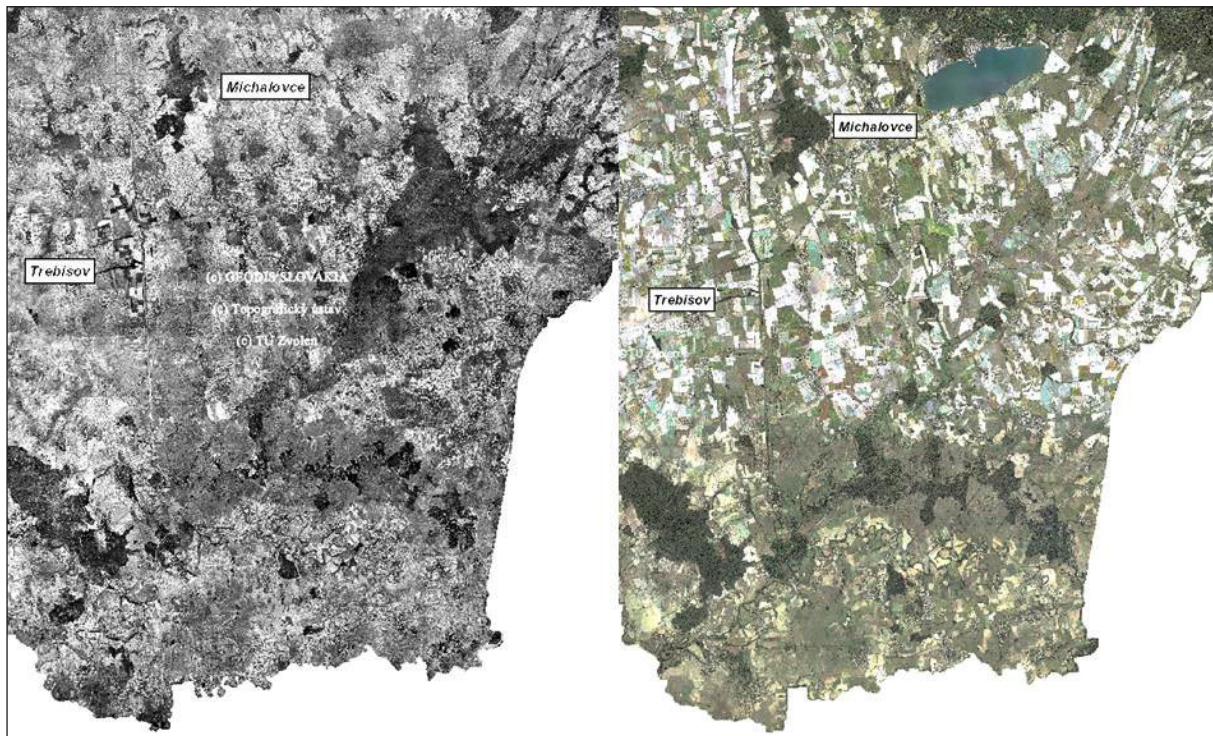
Figure 1. Aerial photos of the VSN area in 1950 and 2010 [<http://mapy.tuzvo.sk/HOFM>]

According to a survey of the Technical University in Zvolen [Technical university Zvolen 2011], the situation of the water management facilities can be compared by looking at the aerial photographs of the territory in 1950.

In Figure 1 you can see extensive wetlands in the area of the current Šírava water reservoir.

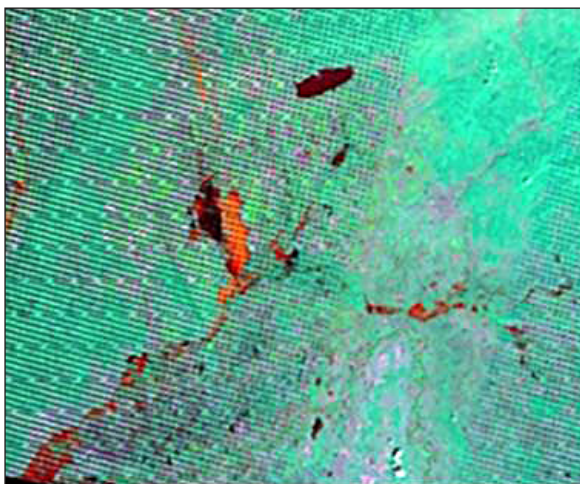
Figure 2. VSN flooded areas during the flood 06/06/2010 (red parts) LANDSAT [VSN 2010]

Aatellite images of Landsat show the consequences of floods in May 2010 where you can see the flooded areas along streams in the VSN.
