## CULTURAL LANDSCAPE, FLOODS AND REMOTE SENSING

The dynamics of the cultural landscape is associated with the penetration of people into the natural landscape, the settling and adaptation to the needs of the society and its development. Climate creates the decisive influence, specifically the form of extremely high rainfall causing flooding. Adverse impact on the cultural agricultural landscape is mainly the submersion time. This time depends on the configuration of the terrain, its disposition and the existing drainage ditches in the area, ensuring the drainage of the flood to the recipients. Long-lasting floods have stipulated taking measures for the protection of the area from flooding by building dikes and drainage of the flood from the area. Identifying the extent of extreme floods and zones of permanent waterlogging is currently provided by modern technology which allows recording satellite images in different spectral bands. Within the basic distinguishing signs mainly accruing is used and it is possible to track changes of the extent of flooded areas and thus identify problem areas insufficiently protected against long-term flooding. Consequently, it is possible to solve

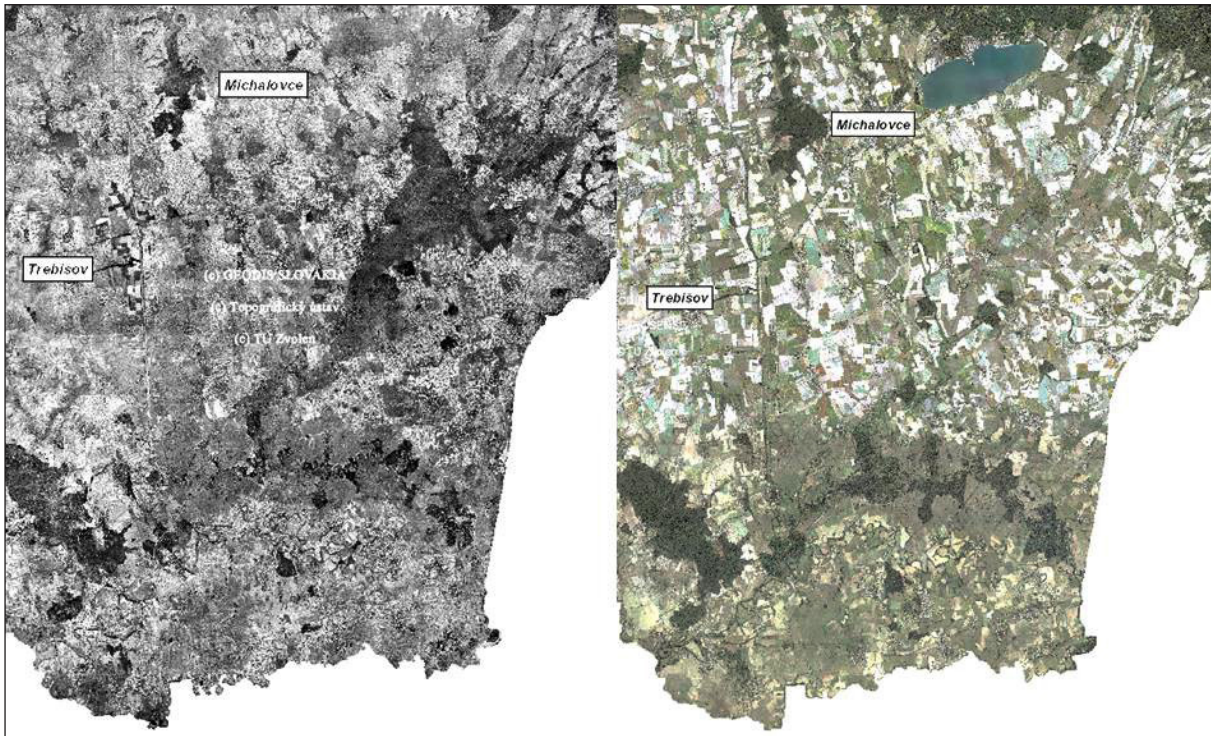
In Figure 1 you can see extensive wetlands in the area of the current Šírava water reservoir.

Figure 1. Aerial photos of the VSN area in 1950 and 2010 [<http://mapy.tuzvo.sk/HOFM>]

According to a survey of the Technical University in Zvolen [Technical university Zvolen 2011], the situation of the water management facilities can be compared by looking at the aerial photographs of the territory in 1950.

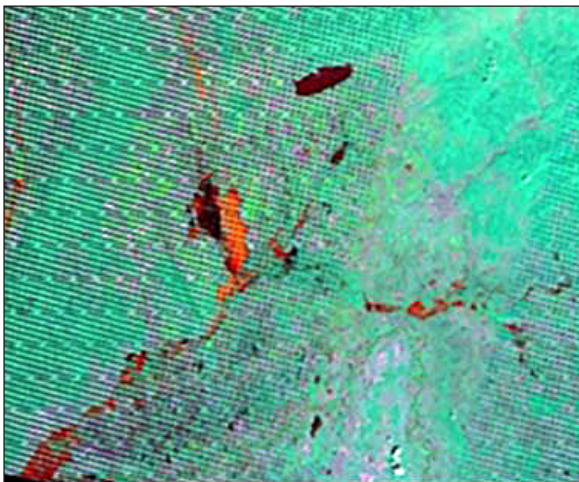
Figure 2. VSN flooded areas during the flood 06/06/2010 (red parts) LANDSAT [VSN 2010]

Aatellite images of Landsat show the consequences of floods in May 2010 where you can see the flooded areas along streams in the VSN.

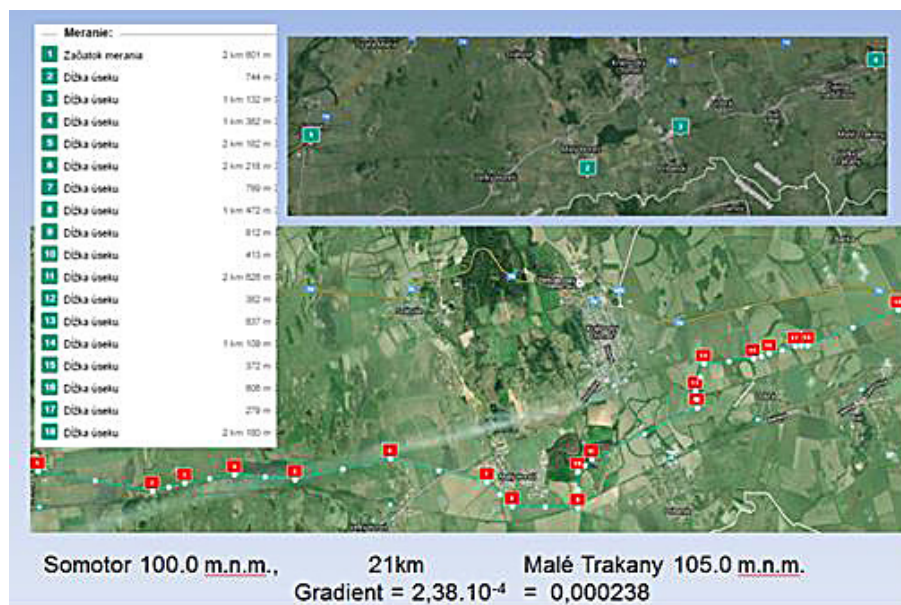
The biggest problem with runoff is in the southern part of the VSN, which is drained by the channel Somotor (Fig. 3). The channel diverts water from the large flat area, which has a slight slope from the east to the west. At the channel length of 21 km the altitude difference is only 5 m. Therefore, the slope of the area is only 0.000238. Particularly problematic is the flow profile that is largely overgrown and clogged with sediments floated from the surrounding land. Channeling water at high water levels in the river provide drainage pumping stations which, however, have little activity since the pump capacity exceeds the

Figure 3. Channel Somotor (Google Map)

potential flow of water through the channel, and flow-channel area is not able to transport such amounts of water to which the filling station is designed. [Kotorová, Kováč 2013].

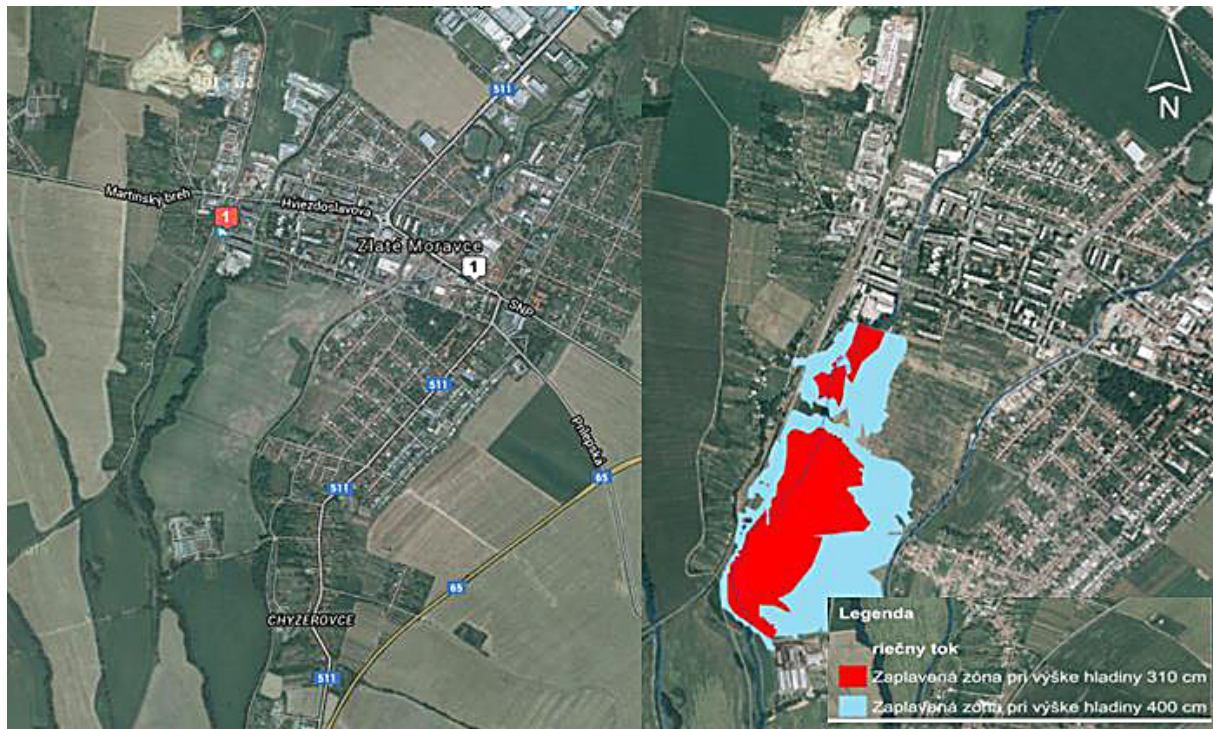
**Figure 4.** Flooded agricultural land in the region Zlaté Moravce with the water level 310 and 400 cm (Simulation) [Zorád 2010].

The situation is similar in Western Slovakia in the river basin of Žitava (Figs. 4 and 5).

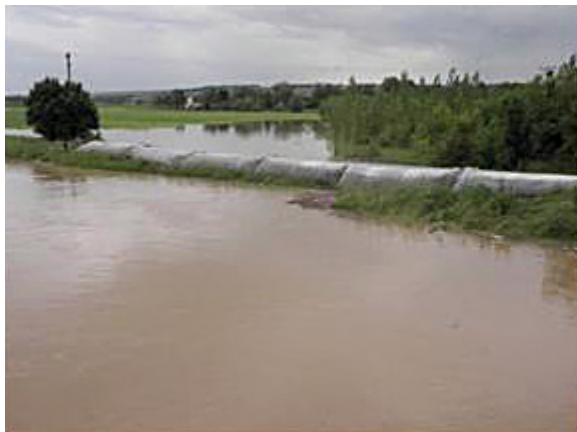
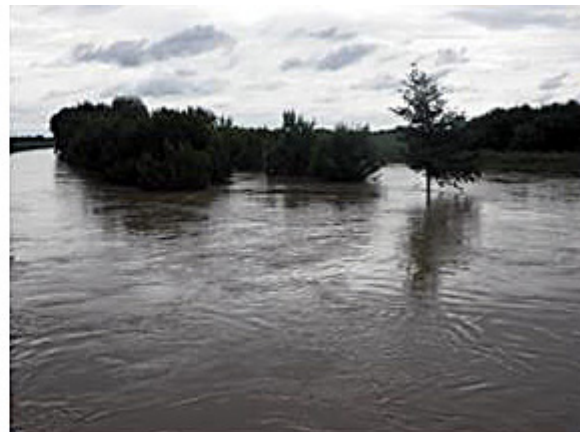
In the late May and early June in 2010 abundant rainfall in the basin Žitava caused the outpouring of water from the stream channel, and a flow of Q1000 was recorded. The attached photos show the flooded area near the village of Maňa [Flood 2010].

**Figure 5.** Farmland flooded during floods on Žitava, 2010 (Photo by D. Húska)
