CULTURAL LANDSCAPE, FLOODS AND REMOTE SENSING

The dynamics of the cultural landscape is associated with the penetration of people into the natural landscape, the settling and adaptation to the needs of the society and its development. Climate creates the decisive influence, specifically the form of extremely high rainfall causing flooding. Adverse impact on the cultural agricultural landscape is mainly the submersion time. This time depends on the configuration of the terrain, its disposition and the existing drainage ditches in the area, ensuring the drainage of the flood to the recipients. Long-lasting floods have stipulated taking measures for the protection of the area from flooding by building dikes and drainage of the flood from the area. Identifying the extent of extreme floods and zones of permanent waterlogging is currently provided by modern technology which allows recording satellite images in different spectral bands. Within the basic distinguishing signs mainly accruing is used and it is possible to track changes of the extent of flooded areas and thus identify problem areas insufficiently protected against long-term flooding. Consequently, it is possible to solve the

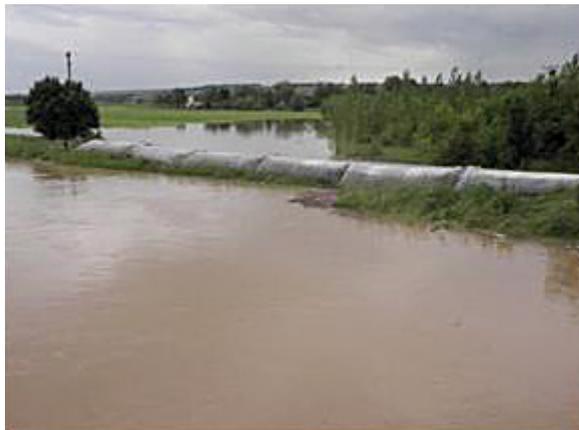
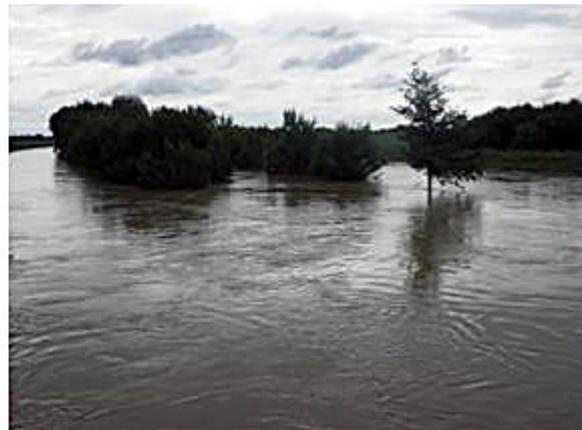
Figure 5. Farmland flooded during floods on Žitava, 2010 (Photo by D. Húska)

The situation is similar in Western Slovakia in the river basin of Žitava (Figs. 4 and 5).

In the late May and early June in 2010 abundant rainfall in the basin Žitava caused the outpouring of water from the stream channel, and a flow of Q1000 was recorded. The attached photos show the flooded area near the village of Maňa [Flood 2010].
