Assessment of the environmental condition in the area of the closed landfills of Krakowskie Zakłady Sodowe Solvay

ABSTRACT

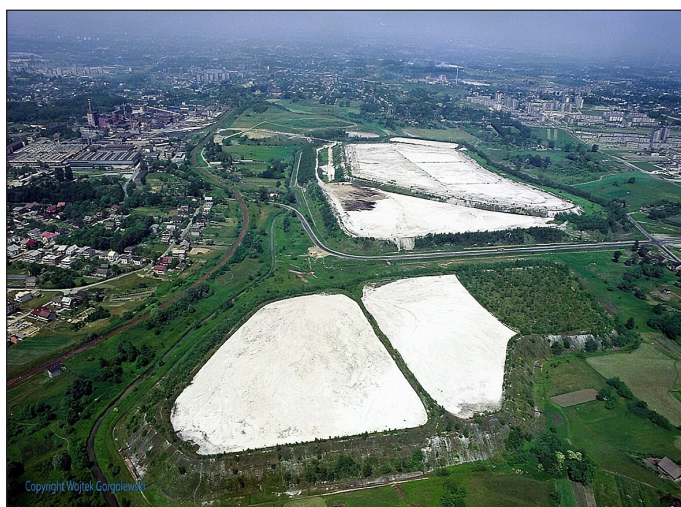
Figure 1. The sedimentation ponds before reclamation (Photo by W. Gorgolewski) [<https://krakowznieba.pl/lagiewniki-borek-falecki-i-zaklady-solvay/>]

Due to the large amounts of post-production waste generated at the same time (6000 m^3 /day, approximately 9–10 m^3 for each tons of product), sediment ponds were built, in which post-production sludge was deposited. To build the embankments, among others, furnace ashes, slag, unburned limestone and clay (soil material) from nearby construction sites were used. The crown of the embankments reaches 20–30 m above the level of the Wilga River. The following were deposited in the sediment ponds: calcium carbonate (CaCO_3), calcium chloride (CaCl_2) and other compounds: SiO_2 , P_2O_5 , CaSO_4 , MgSO_4 , BaSO_4 , NaCl as well as flints and limestone granules [Gliniak et al., 2014]. Until the plant was closed in 1986, 5 million tons of environmentally harmful post-production waste were deposited in tailing ponds, covering an area of approximately 100 ha. Due to the color of the deposited waste, which often had white dust floating above it, the sediment ponds came to be called “White Seas” (Figure 1). After the plants were closed, some of the sediments were reclaimed, to a greater or lesser extent [Rywczak, 2021, Okrutniak, 2011].

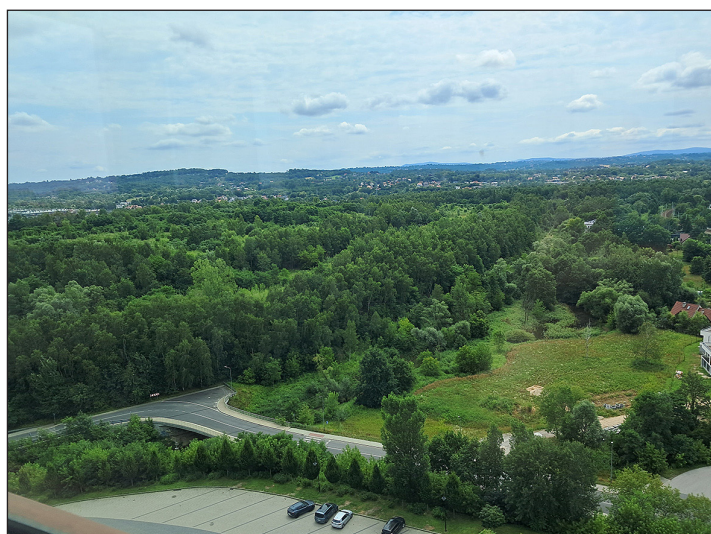
Figure 2. The sedimentation ponds after reclamation

Poland is located there: the JPII Center, connected by a walking footbridge to the Sanctuary of Divine Mercy in Łagiewniki. Sediment pond No. 2 was reclaimed mechanically and partially biologically. The top of the landfill was covered with a layer of clean soil, hydroseeding was used (humus-producing species: legumes and grasses), and the slopes were planted with woody plants, improving the stability of the embankments (Figure 2). The third settler was not reclaimed, it became overgrown on its own as a result of natural succession, and currently there is a dog park there, eagerly used by Krakow residents and their pets. A railway line runs along the western border of the tailing ponds (Kraków-Zakopane), and a “shortcut path” runs through them, connecting the Kurdwanów Nowy and Wola Duchacka housing estates with the “Zakopianka” shopping center [Kupiec et al., 2012, Sroczyński, 2008].

Currently, the sediment ponds are naturally green. They create a hilly, irregular landscape, and the vegetation that has invaded this area, despite the environmental conditions, has formed a dense cover, also on the top. At sediment settler No. 2, there is a site of giant horsetail, patches of pink willow-herb, spindle bushes, and rare species of birds, such as the white-breasted warbler and landrail (*Crex crex*). Unfortunately, through succession, invasive species also entered the area, such as the ubiquitous goldenrod and small-flowered impatiens (Figure 2). The Wilga River meanders between the sediments ponds. In the past, one of the ideas for developing the area was the construction of a golf course, the investment has not been completed (in the area of sediment pond No. 2, the remains of the construction can

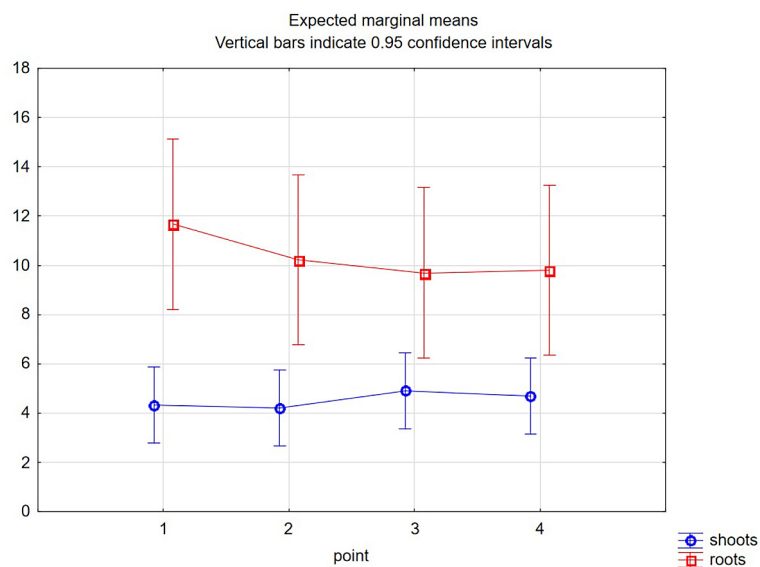
Figure 4. Lengths of shoots and roots in water extracts (100% concentration) from particular sampling points

The results of phytotoxicity tests against *Lepidium sativum*, carried out on water extracts from the soil samples taken from soda sedimentation ponds, mostly did not show a negative impact of the tested material on the early growth of the test plants. In all tested solutions, the average root lengths in the water extracts from the tested soils were shorter than in the control sample (Figure 3). After performing the ANOVA analysis and Tukey's post hoc tests, it was found that only in the sample taken from point No. 2 (the soil from not reclaimed sedimentation pond, higher level, but from an excavation for a pond, sediments on surface layer), at a concentration of 25%, the root length differed significantly from the root length in the control sample. For none of the tested points, there were no statistically significant differences in root length between individual concentrations. No such differences were found between water extracts with a concentration of 100% from all soil samples (Figure 4).

In the case of above-ground shoots of test plants, the average value of their length is also higher in the control sample than in the other samples (Figure 5). However, the ANOVA analysis and Tukey’s post hoc tests did not show any statistically significant differences (Figure 4).

root length value) and the soil from point No. 4. In the case of cress, the average root length is also higher in the control sample than in the other samples. When analyzing Figure 4, it can be assumed that these differences will be statistically significant for sampling points No. 2 and 3 (sediments on top/from surface layer). This is confirmed by ANOVA analysis and Tukey's post hoc test. For cress, two significantly different groups of root lengths can be distinguished: points No. 1, 3 and control (for them, there are no statistically significant differences in root lengths between groups) and points No. 2 and 3 with clearly shorter roots (the roots from these two points also do not show significant differences in length between groups). *Sinapis alba* seeds responded differently to soil properties. In the case of this plant, the longest average root value was recorded for the soil from point No. 1. Their length is significantly different from the *Sinapis alba* roots growing on the land from points No. 2 and 3 (where white sediments were visible in the soil to the naked eye) and the control. There are also significant differences between the root lengths for points No. 3 and 4.

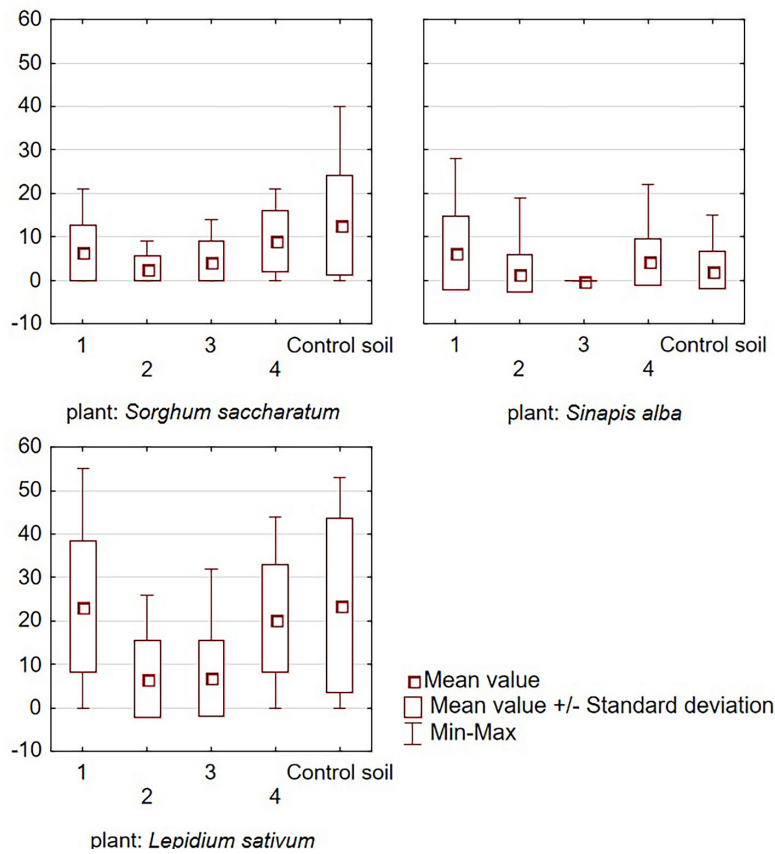
Figure 6. Range of root lengths of plants growing on soil taken from Solvay settling ponds

When analyzing the results of the Phytotoxkit test, it can be noticed that for *Sorghum saccharatum* the average root length is clearly higher in the

control sample than in the case of the other points (Figure 6). The ANOVA analysis (Figure 7) and Tukey’s post hoc test confirm that these are statistically significant differences for the soil collected in points 1–3 (i.e. from sediment pond No. 2). It can therefore be concluded that these soils are toxic to *Sorghum saccharatum*. Significant differences in root length were also observed between the soil from point No. 2 (the smallest average

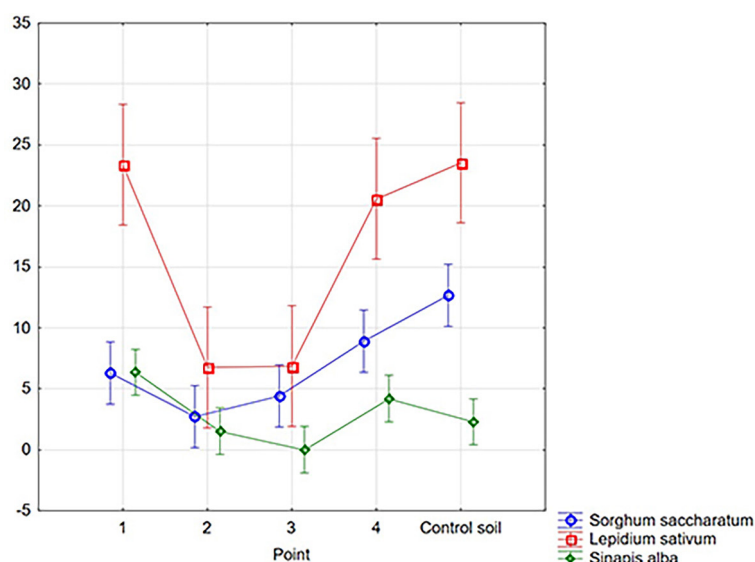
Figure 7. Root lengths of plants growing on soil taken from Solvay settling ponds (ANOVA analysis)

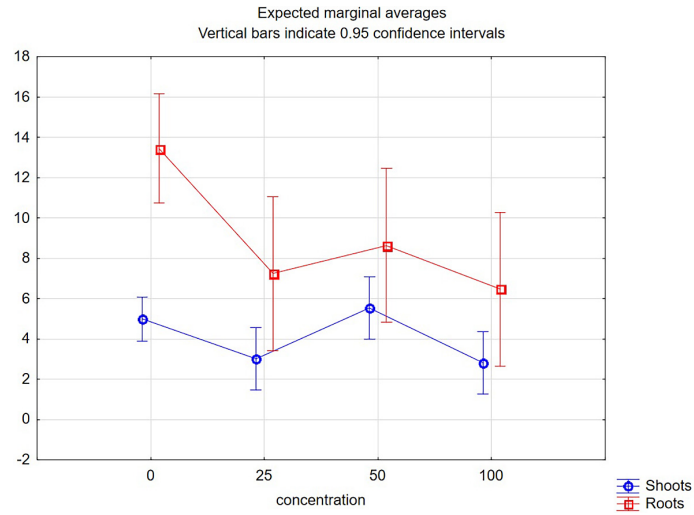
Figure 8. Lengths of *Lepidium sativum* roots and shoots in a water sample taken from the Wilga River before the river entered the settling ponds' area

A phytotoxicity test against *Lepidium sativum* was carried out on the water samples taken from the Wilga River. The research was carried out on the water samples taken before (WBST) and after (WAST) the river flowed through the sediment ponds. For sample WBST, clearly longer roots and shoots were observed in the control sample than in the tested water at different concentrations (Figure 8). ANOVA analysis and Tukey's post hoc test confirm that these differences are statistically

significant. However, based on statistical analysis, no significant differences were found in the length of shoots and roots of plants germinating in different concentrations of the tested water.

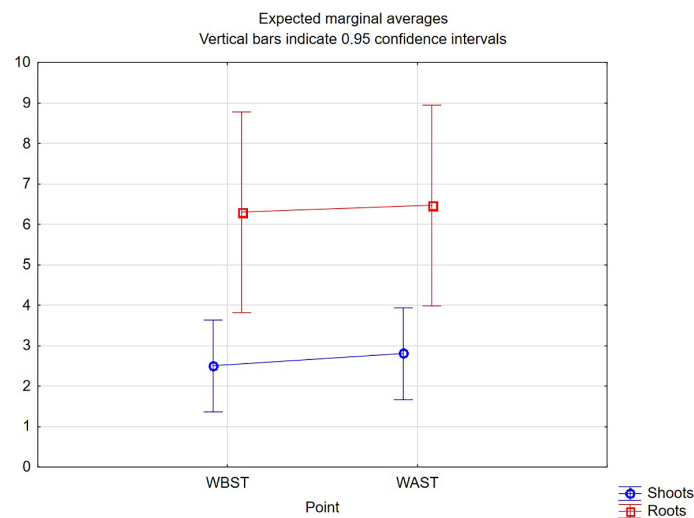
Figure 10. Lengths of *Lepidium sativum* roots and shoots in a water sample taken from the Wilga River before and beyond the area of settling ponds without dilution

The lengths of shoots and roots were also compared in samples with 100% concentrations taken at both points (Figure 10). No significant differences were found in their lengths. On the basis of the tests performed, it can be concluded that despite the increase in ion concentrations (Table 1) in the water collected after the river flowed through the sediment ponds, it did not result in an increase in the phytotoxicity of these waters [Kapanen et al., 2001].
