The intensity of erosion and its causes on the shores of artificial reservoirs: The role of slope gradient and vegetation cover

¹ Faculty of Environmental Engineering, Lietuvos inžinerijos kolegija /Higher Education Institution,
Tvirtovės al. 35, Kaunas, LT-50155, Lithuania
* Corresponding author's e-mail: sinilga.cernuliene@lik.tech

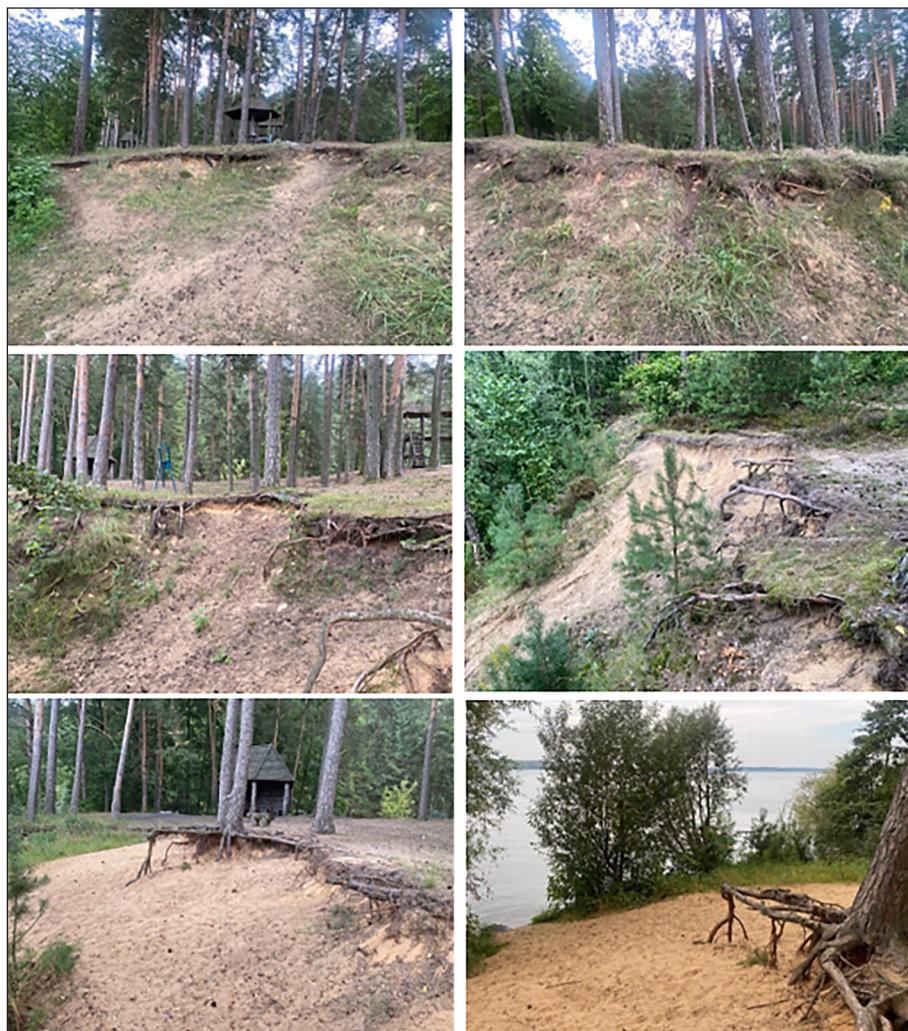
The erosion classes were distributed as follows: class 3 was found in five out of the ten sections whereas class 2 appeared in the remaining five; classes 1 or 0 were not recorded at all (typical images – Figure 2). This means that this section is

Figure 2. Typical examples of shoreline erosion at study site 1

The vegetation cover at this study site is sparse and fragmented. Grass and shrub cover encompasses only 11–28% of the slope area (average ~23%), leaving a large part of the soil exposed to erosion. Vegetation cover indicators are lowest in intensively eroded sections (e.g., 11% in section 8, 13% in section 9), which is consistent with the field signs – erosion at the foot of the slope and root niches – and indicates that the vegetation cover layer no longer performs a protective function here. Class 3 is found not only on the highest slopes (>5 m), but also on slopes of medium height (~ 3.7 m) and a gradient of about 34° , where the cover is significantly reduced (about 20–25%). Meanwhile, Class 2 sections more often coincide with slightly higher percentages of cover (25–28%) or slightly lower slopes (2.6–3.3 m), which leads to the conclusion that the amount

Recreational activities have a significant impact on the destabilization of the banks. There are gazebos and recreational infrastructure in this area, so visitors' flow is high. Intensively trodden paths, campfire sites, and damage to grass cover further promote erosion. In some places, the soil has completely lost its surface layer, so rainwater easily washes away the sand, deepening the slope grooves and forming gullies. Such places become erosion hotspots that are rapidly expanding.

In summary, several unfavorable factors coincide at the first study site, namely medium to high slope height, very poor vegetation cover, and anthropogenic disturbance. Due to this combination, half of the coastal sections fall into the intensive disturbance (3) class, while the other half fall into the moderate disturbance (2) class. From a practical point of view, this indicates priority stabilization sites, primarily, sections with <20–25% vegetation cover, especially when the slope height is >~4.5 m, as this is where erosion processes are most active and spread most rapidly.

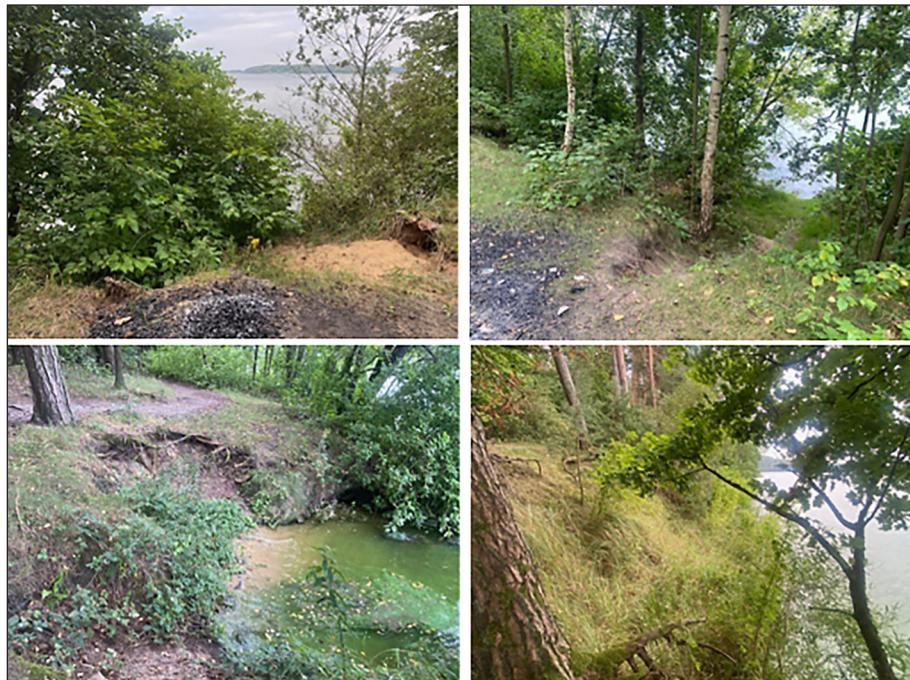
The distribution of erosion classes confirms this picture of stability: 80% of the sections are classified as class 1, which is slightly eroded, while class 2 is found in only two places – where the vegetation cover has decreased to ~56–58% and the height of the bank is greater (about 2.4–2.5 m). This shows that even on flat terrain,

Despite the favorable conditions, isolated anthropogenic risks have been recorded: in some places, illegal campfires and paths trodden by visitors leading directly to the slope have been identified. Such traces locally damage the grass cover and form initial erosion grooves, which, if left uncontrolled, can expand and eventually increase the intensity of erosion. This not only damages the grass cover, but can also cause the soil and roots to burn. Therefore, even relatively stable banks should be monitored, especially where the vegetation cover is reduced or where visitor flows coincide (typical images are shown in Figure 3). Such activities are incompatible with the protection regime of the regional park and indicate that education as well as visitor control in this area are insufficient.

Figure 3. Typical examples of shoreline erosion at study site 2

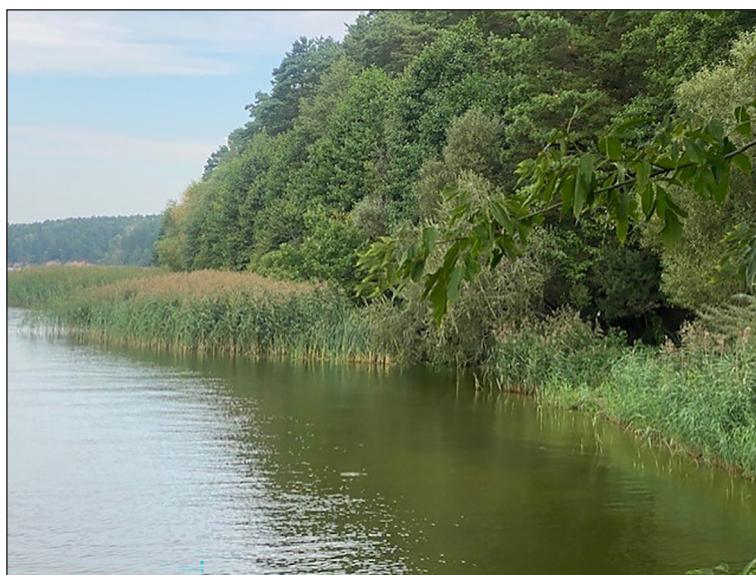
slope (usually around 70–80%), supplemented by a continuous strip of reeds along the shore, which acts as a natural breakwater and helps to stabilize the shoreline (Table 3, Figure 4).

Slopes are gentle to moderate (10–20°); all sections are in erosion class 0–1. The distribution of erosion classes confirms the picture of stability. Classes 0–1 prevail in all sections: class 0 was found in four sections (1, 3, 5, and 8), and class 1 appears in four sections (2, 4, 6, and 7). No moderately (class 2) or intensively eroded (class 3) sections were recorded. The cases where class 1 was identified usually coincide with a slightly higher shore height, about 1.8–2.3 m, and a lower than usual proportion of vegetation cover, about 68–72%, but even in these places, the reed belt cushions the waves and prevents the spread of erosion processes (Table 3).

**Figure 4.** Typical examples of shoreline erosion at study site 3
