INFLUENCE OF EXTREME DISCHARGE ON RESTORATION WORKS IN MOUNTAIN RIVER – A CASE STUDY OF THE KRZCZONÓWKA RIVER (SOUTHERN POLAND)

Keywords: mountain river maintenance, river channel processes, artificial riffle, debris dam reconstruction.

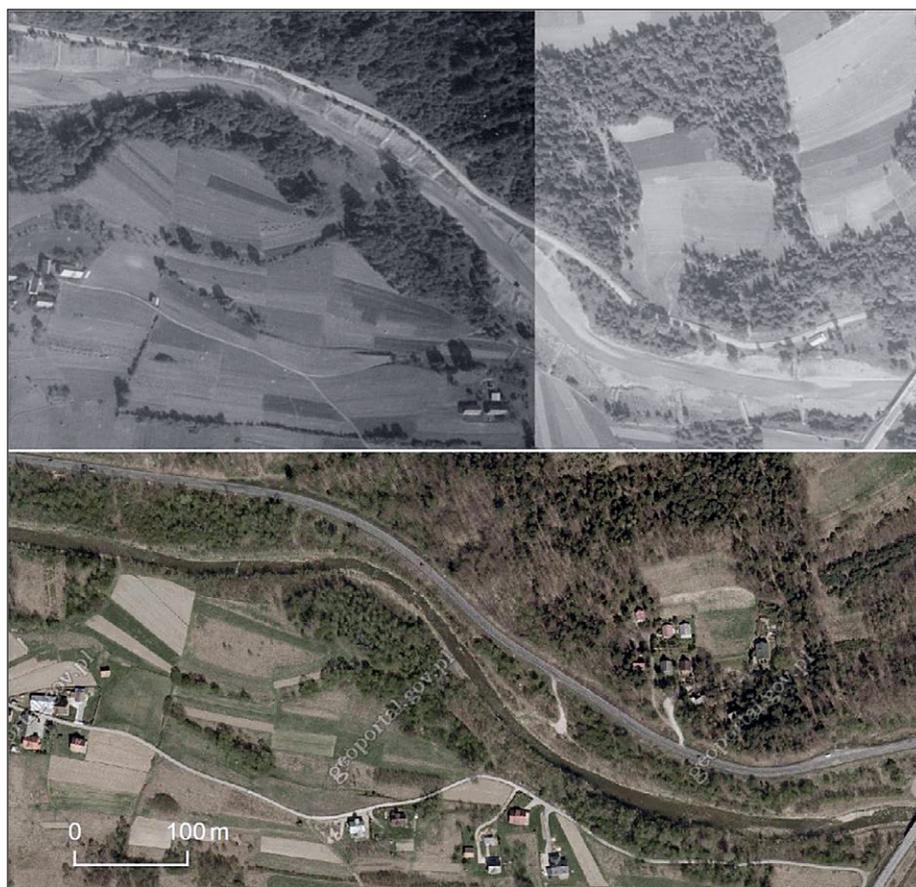
Figure 2. Aerial photos of the lower reach of the Krzczonówka River in 1963 (above) and 2006 (below)

downstream of the debris dam in different years to regulate the flow. Many of the structures were built in the late 1950s and early 1960s. The transverse structures that are seen on the aerial photograph taken in 1963, had been constructed recently before the photo was taken, as the areas between them are covered with soil, but not yet covered with vegetation (Figure 2).

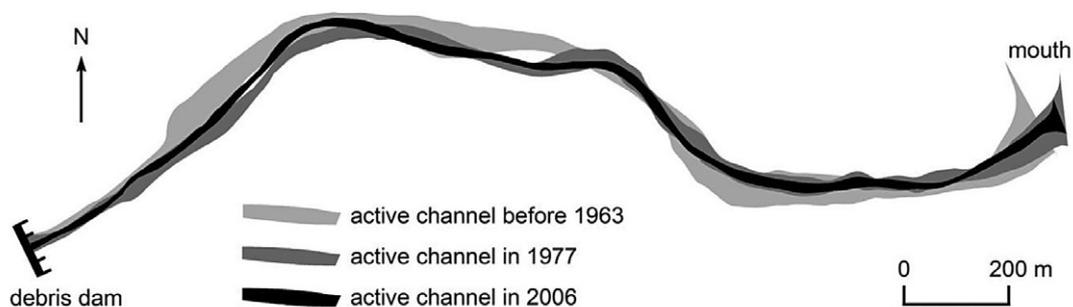
Figure 3. Changes in the course of the channel of the Krzczonówka River in its lower reach

The stream channel of the Krzczonówka River, downstream of the debris dam, was straightened and became much more narrow as a result of the regulation works performed in it (Figure 3).

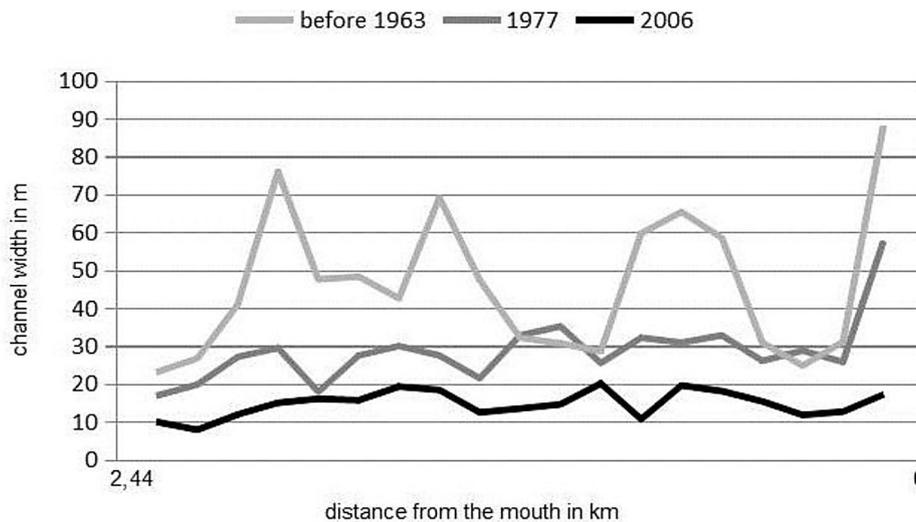
Figure 4. Changes in the width of the channel of the Krzczonówka River in its lower reach

A representation of measurement data on the active channel width of the Krzczonówka River is shown in Figure 4. The active channel was defined as a low-flow channel with unvegetated bars. The measurements made from photograph taken in 1963 cover the channel width from before construction of the longitudinal structures.

The average width decreased over time by the factor of more than three: from 46 m before 1963, down to 29 m in 1997, and down to 15 m in 2006.

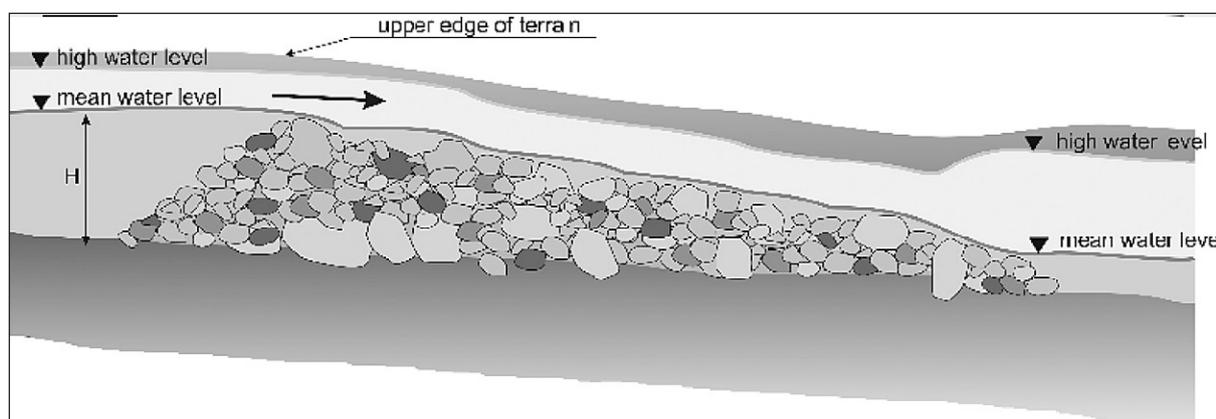
Figure 5. Sketch of a typical riffle, constructed in the Krzczonówka River – a longitudinal profile

The height of a riffle crest is different for different structures. It depends on local conditions, and ranges from 0.6 to 1.2 m (Figure 5). Raising the crest of natural riffles causes a decrease of unit stream power at the end of the pool as well as on the riffle crest [Bojarski et al. 2005]. This limits sediment transport, and consequently decreases erosion. Moreover, riffles are to introduce variety into the longitudinal profile of the stream and to decrease the slope of stream water surface. Similar structures were already described multiple times in terms of project planning and design [Kapitzke 2010, Mooney et al. 2007], as well as their construction [DVWK 2002, Radecki-Pawlik 2013, Rosgen 2006, Ślizowski 1993, Ślizowski and Radecki-pawlik 1999], durability [Torre 2001] and their impact on the stream channel [Darby and Sear 2008, Łapuszek and Lenar-Matyas 2013]. In the case of the researched reach of the stream the project of building the riffles is tied to the lowering of the debris dam. These are different conditions than the ones described before, and that is why they are exceptional.

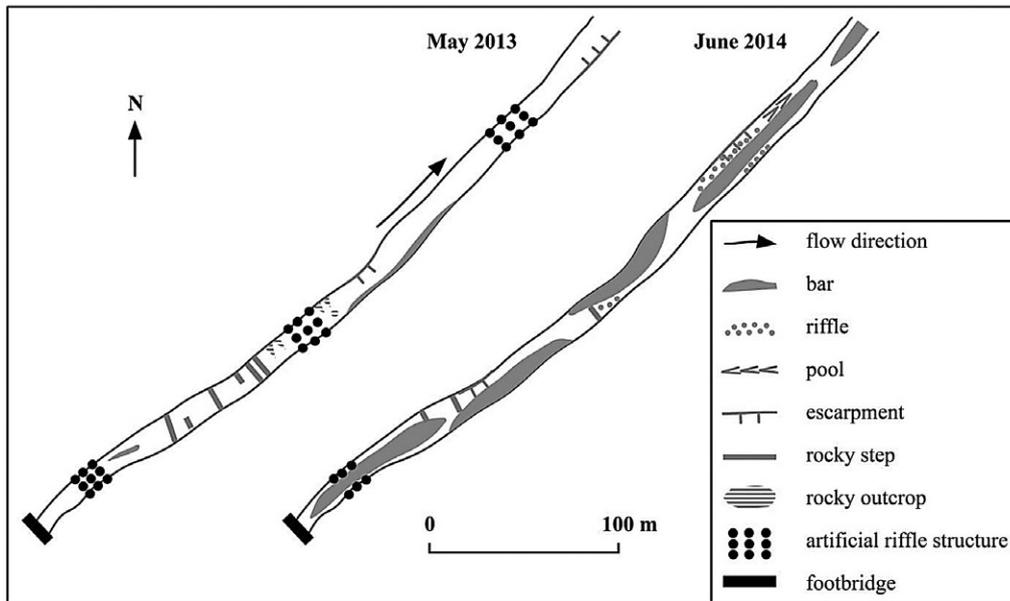
Figure 6. Plan view of the stream channel segment below the debris dam

The mapping performed in June of 2014 showed great changes in the shape of the studied river channel reach. First, the number of mid-channel bars increased significantly (Table 1). Dimensions of point bars and mid-channel bars also increased (Figure 6). The number of cutbanks increased while the number of rock steps and outcrops decreased. Deposition is the primary process transforming the stream channel. This occurred thanks to a large supply of sediment during the flood stage in May of 2014. The volume of sediment load exceeded the river's capacity. The material supplied was delivered from the upstream reach of the stream channel, which lies above the debris dam. It took place due to the lowering of the dam. The material was also delivered from cutbanks. There were some segments of the stream channel, where the bank retreated several tens of centimeters. Some bank reinforcements were also heavily damaged. The structures of most new riffles are not noticeable. There is only a slight change in the stream slope angle, in the spots where they are found.

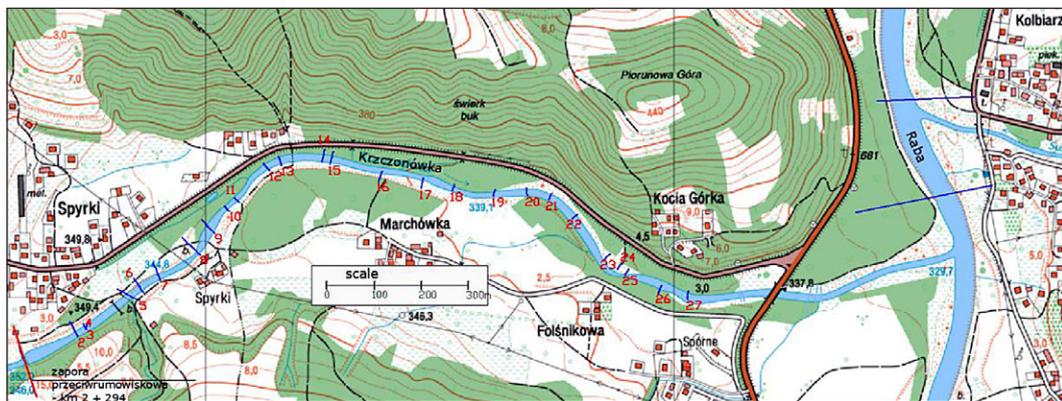
Figure 7. The lower reach of the Krzczonówka River ending at its mouth. Locations of cross sections, where measurements were performed in 2013 and then again in 2014, are marked on the map

- the spring of 2013 – measurements of 22 cross sections of the stream channel and surrounding areas, water level measurements (Figure 7),
- the autumn of 2013 – measurements of six cross sections of the channel within the reservoir area on the upstream side of the debris dam, it was necessary to perform these measurements before the lowering of the crest of the dam in order to be able to control the intensity of headward erosion (causing a headcut);
- the spring of 2014 – measurements of cross sections were repeated in all locations where they were performed before, below and above the dam (Figure 7), measurements of new cross sections were also performed at sites strongly transformed in terms of shape with respect to their status of one year ago.
