Estimation of Organic Soils Subsidence in the Vicinity of Hydraulic Structures – Case Study of a Subirrigation System in Central Poland

Andrzej Brandyk^{1*}, Ryszard Oleszczuk², Janusz Urbański³

Keywords: organic soils, subsidence, sub-irrigation system, hydraulic structures, technical parameters, culverts and culvert-gates.

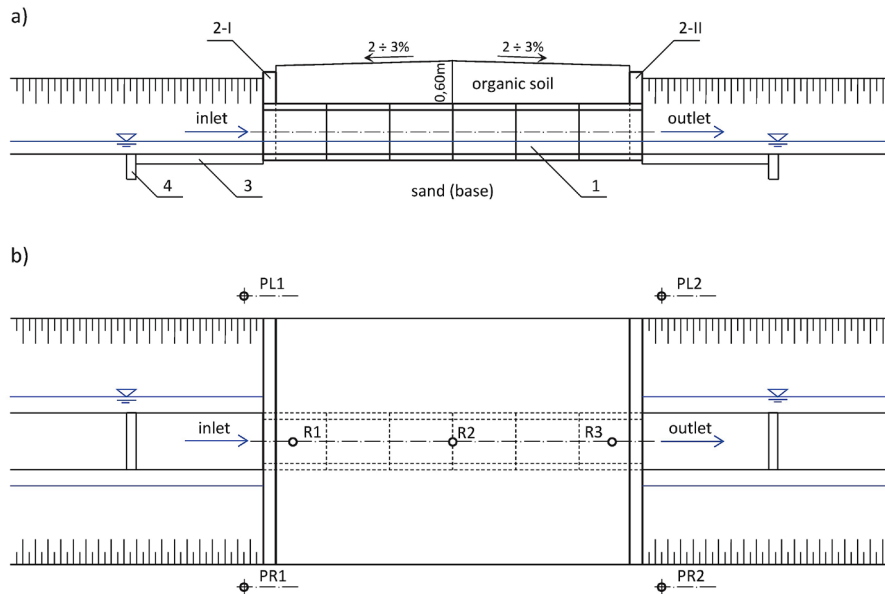
outlet. The elevations of the protections in reference to the ground level were examined at the inlet and the outlet of the culverts and culvert-gates at their left and right side with the use of geodetic patch (Figure 3).
