## Fish Pass Functionality in Relation to the Dynamics of Hydrological Conditions in the Upper Course of the River Iskar (Case Study)

The investigated fish pass is a part of a low-head hydrostatic pressure machine (HPM) located on an existing weir in the upper Iskar River. Monitoring of the hydraulic features of the fish pass was performed under different hydraulic conditions. Diversity and abundance of the local fish fauna was investigated with the aim to verify target fish species. A major limiting factor for using of the fish pass during flood periods was high water velocity (both inside the fish pass and at the fish pass downstream entrance), while during the low water discharge periods it was the insufficient water depth in some pools and the significant differences between the water levels in adjacent pools. The difference between the water levels at the entrance and exit of the fish pass reduces the chances for access of small-sized fish species. Some measures for improving fish pass functionality were developed. Several re-construction solutions were proposed in an attempt to help solving the identified problems.

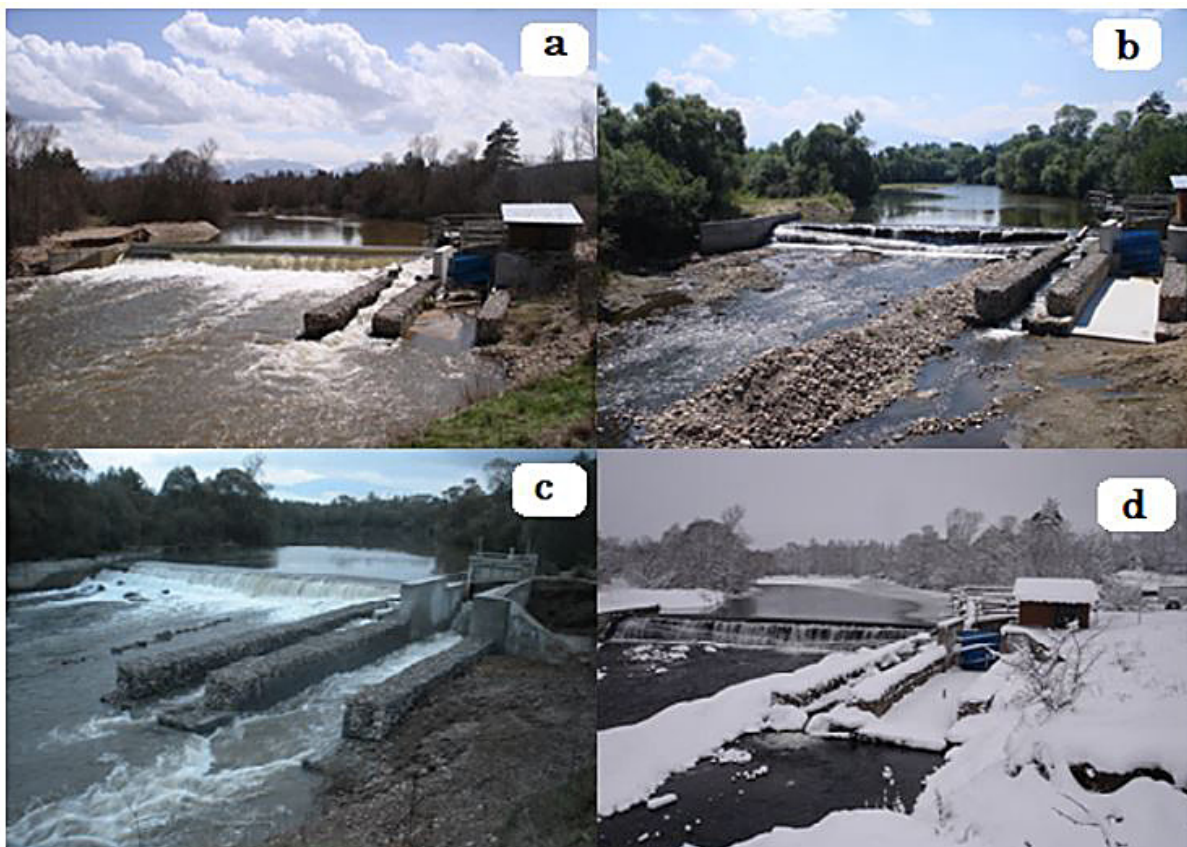
**Figure 6.** Different hydraulic conditions of the river Iskar at location Mechkata: April (a), June (b), September (c), December (d)
